Rusting in Raro

This article is a true description of an AECS technical help desk problem and how it was solved.

Vehicle: Daihatsu Hi-jet 1999 Engine EF-SE 659cc, Japanese import

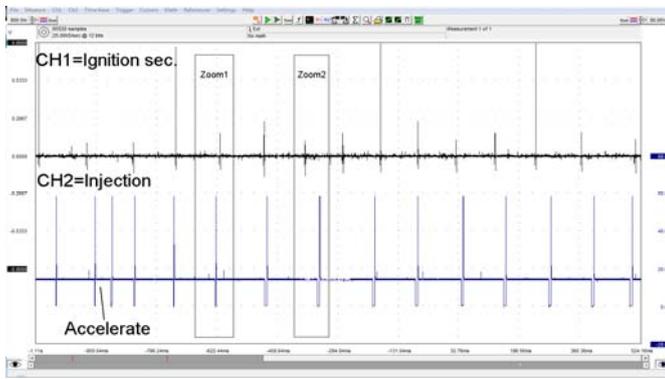
Figure 1: ATS 801 dual channel scope recording of ignition over injection. Highlighted are the two areas where the next 2 pictures/measurements are taken.

In the above scope measurement is clear to see that acceleration takes place (one extra injection pulse). It is also clear to see that not immediately the injection pulse width increases (bogging down). Less obvious is that the injection and ignition timing are running out of phase (just after the box “zoom2”), creating a further lack of fuel.

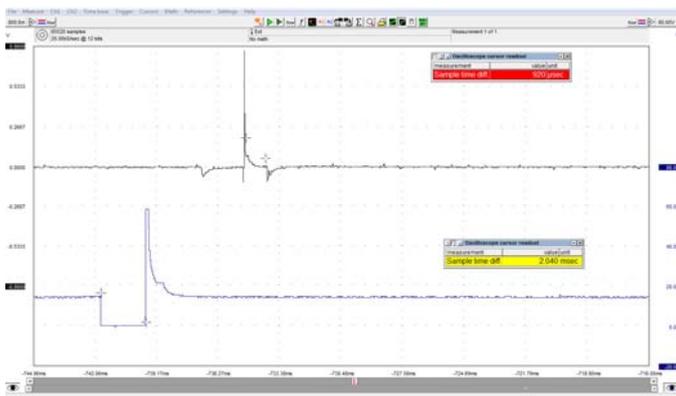
Figure 2: Zoomed in on box “zoom1”.

In the zoomed picture, it is clear to see that the ignition (0.92msec) during acceleration is not great but certainly not the cause of the misfiring. The injection however at just over 2 msec is absolutely not enough, these are idle values.

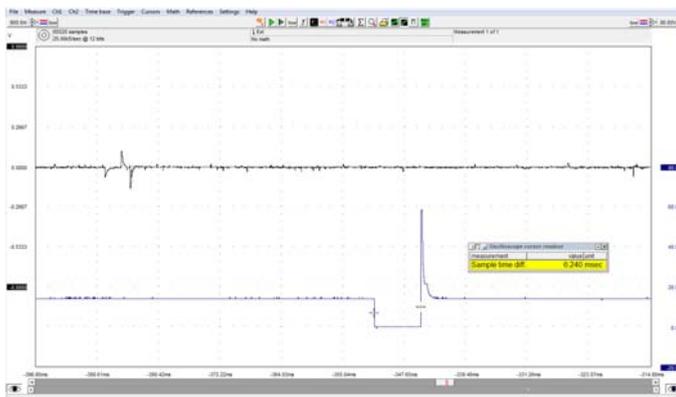
Figure 3: Zoomed in on box “zoom2”.

Too late! The injection has suddenly increased to a steady 6.24 msec some time after acceleration.

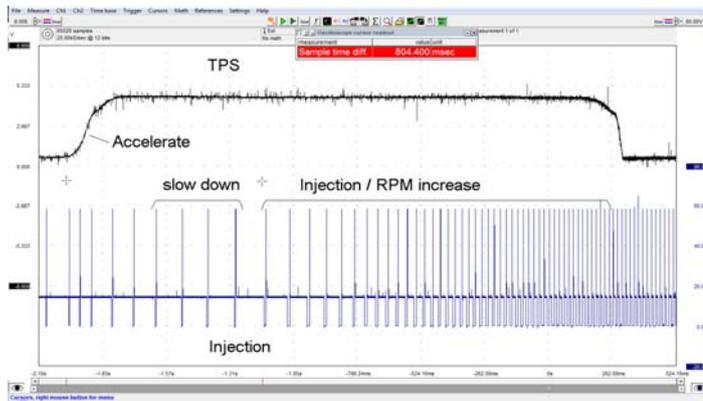
In the figure 4, it is again visible where acceleration takes place (double injection pulses where the TPS voltage increases). It is also clear, even without zooming in, that the injection pulse width does not increase after the acceleration. The frequency of injecting shows clearly that the engine actually slows down. Than all of a sudden, the

Figure 4: ATS scope recording of the TPS vs the injection

injection pulse width increases and the RPM picks up. At the end of the pattern when the accelerator is released the injection pulse width does not back down, until the rev's fall to a low level. It almost seems as if the ECU does not receive the hashy but other than that reasonable okay TPS signal.

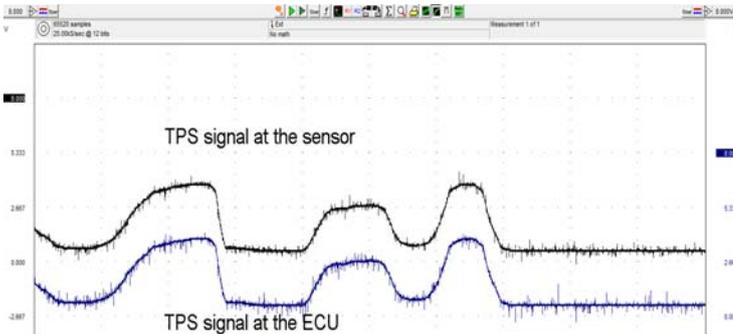
Figure 5: ATS scope recording of the TPS vs the injection.

The measurement revealed virtually no difference between the signal voltage at the sensor and at the ECU. The "Math" function of the scope (Ch1-Ch2) confirmed this.

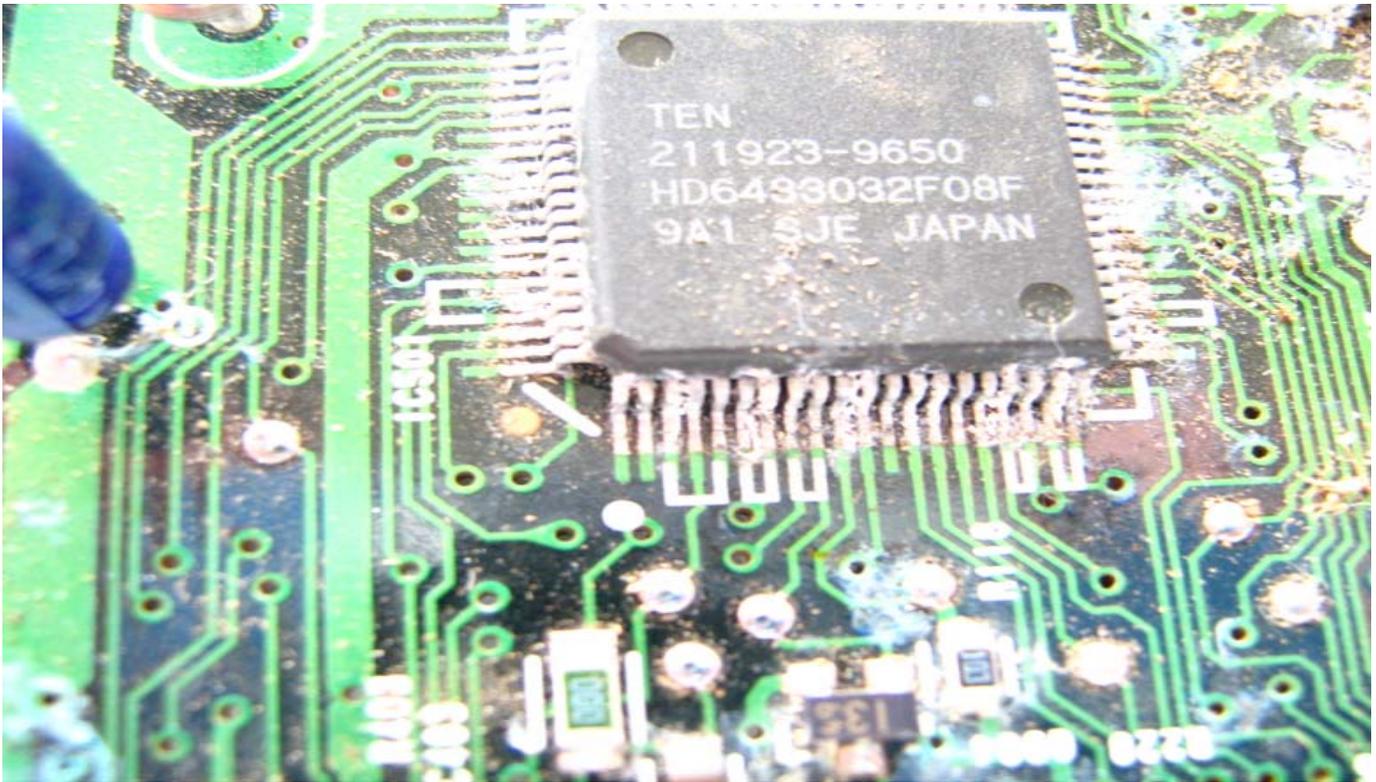
Figure 6: Daihatsu's ECU internal.

The ECU's printed circuit board (figure 6) looked like a veggie garden at a Rarotonga beach! Sand, corrosion and bits stuck between the CPU's pins shorting inputs and outputs together. Only the ocean waves where missing!

Time for a new ECU, not a chance that this one can be repaired. A new one was ordered and fitted, the vehicle runs fine now, although only on three cylinders....
