Attention Atenza

Vehicle: 2002 Mazda Atenza, 4 cylinder variable cam timing, 2 DIS ignition coils, fresh Japanese import.

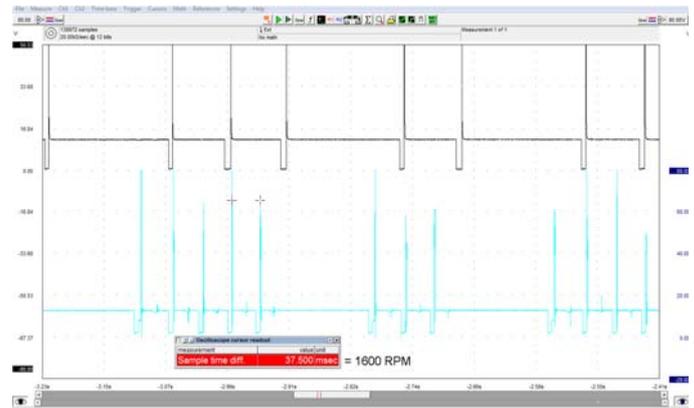
Picture 1: *ATS 5000 2 channel recording of injection vs ignition at high idle while surging.*

Clear to see that the ECU makes a mess of the ignition and the injection, as soon as the revs go over around 2000 RPM (varies). This points directly to a calculation error between the crank/cam speed and position signals, so the next measurement should be crank shaft and/or camshaft sensor.

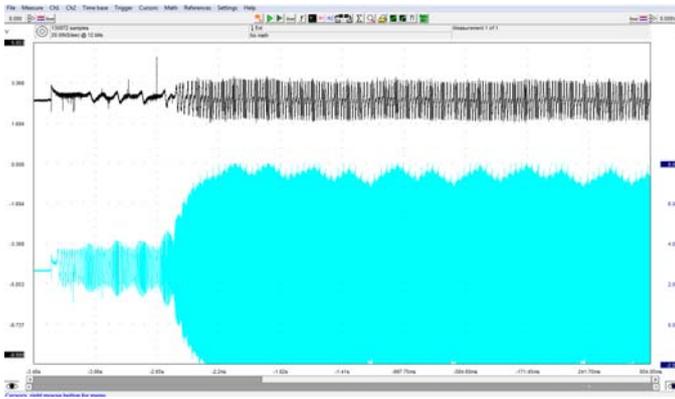
Picture 2: Recording of camshaft and crankshaft sensors from startup on the patient.

The recorded pattern in Pictures 2 & 3 shows clearly that the engine is 'hunting' at around 1600 RPM. It also shows that both sensors produce a seemingly good signal. Perhaps we were wrong with our conclusion....

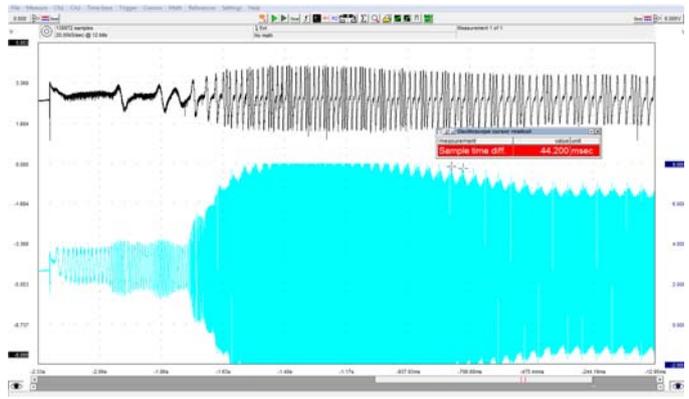
Picture 4: ATS scope recording from YES colleague on a similar vehicle.

This pattern (Pictures 4 & 5) looked very similar to the first, except when the signal was zoomed in and analysed. Please look at the difference in phase offset! Roughly estimated the difference between the two vehicles is 18 degrees.

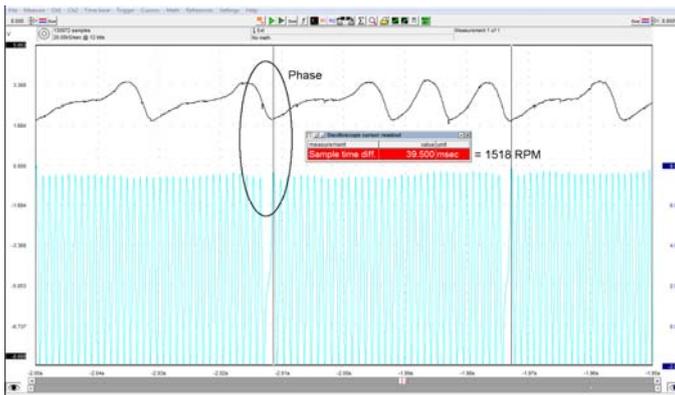
Picture 3: Recording of camshaft and crankshaft sensors zoomed in. Please note the phase offset between the cam and crank shaft.

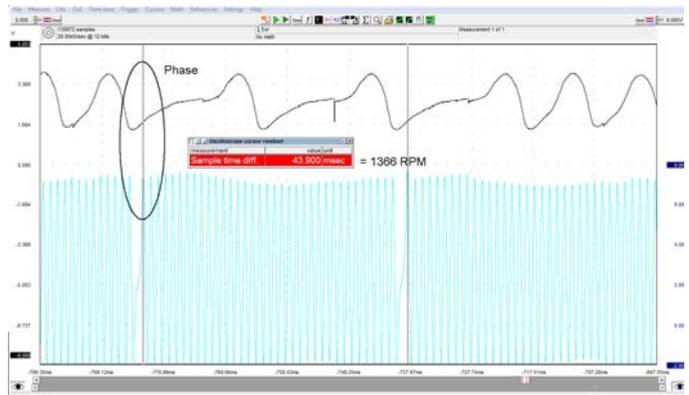
Picture 5: Crank and cam shaft sensor signals zoomed in. Please note the difference in phase offset!

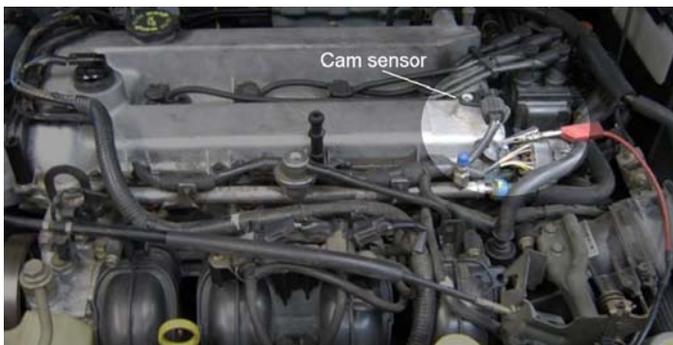
Picture 6: Engine bay with cam sensor highlighted

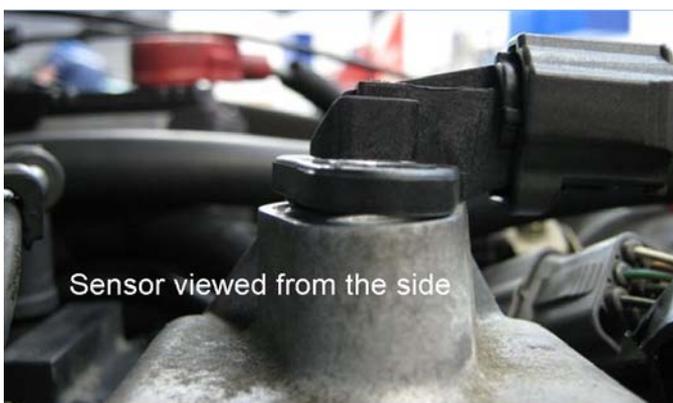
Picture 7: Cam sensor sits in a funny angle, (also with the bolt in) could this be why there is a signal offset?

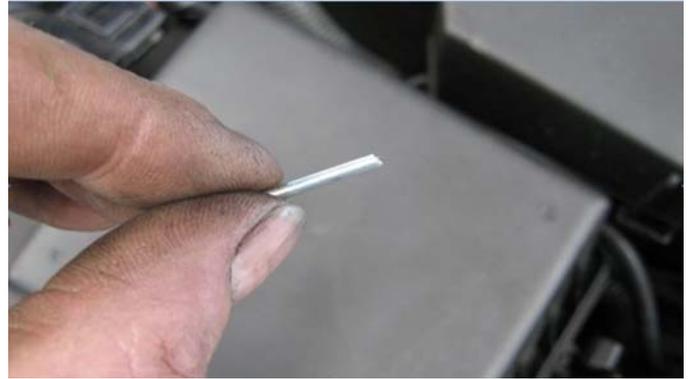
The sensor got removed and a small piece of steel, cut from a split pin or something was found under the sensor's seat

Picture 8: Split pin tab removed from under the base of the cam sensor!

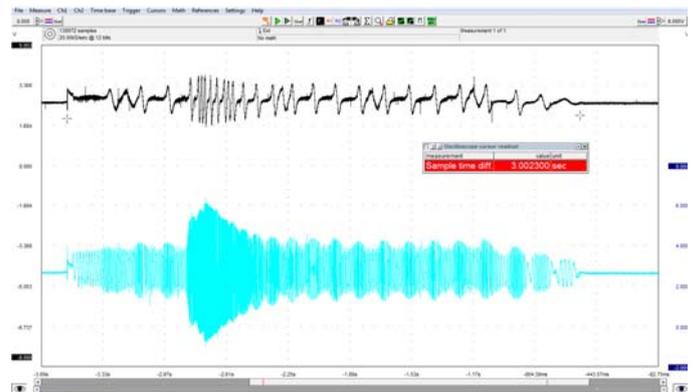
Picture 9: Crank cam recording of the 'patient' with the cam sensor fitted properly

The engine gave one beat during winding over and then died again, this had made it worse! Better zoom in on the phase offset.

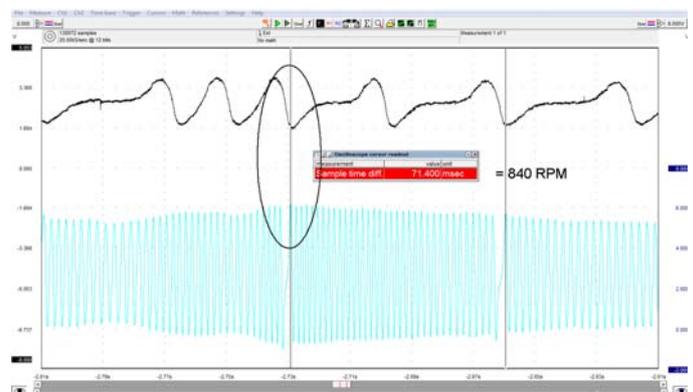
Picture 10: Cam crank phase offset on the patient with sensor fitted properly...

The signal offset has shifted in the wrong direction! The phase offset is another approximately 4 degrees further away from the position of where the signal is on the good vehicle.

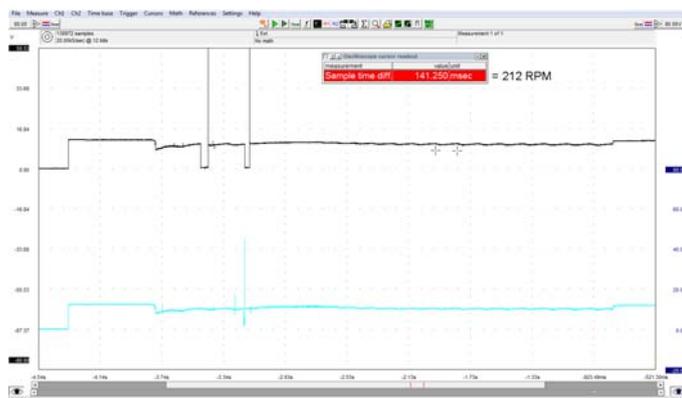
Injection vs ignition on patient with camshaft sensor properly fitted.

Now the picture becomes clear, it seems that the cam timing is out and that someone has tried to compensate for this by altering the camshaft sensor's position! Very Clever!

It was decided to remove the front of the engine and inspect the cam timing. It was found that the timing was out one or two teeth. The chain was refitted and timed correctly. The engine runs fine now. Some people move at extraordinary lengths to hide a job gone wrong, but this one beats all the
