Direct injection bad connection

This article is a true description of an AECS technical help desk problem and how it was solved.

Toyota 1999 Toyota Nadia with a 3S-FE D4 Direct injection engine.

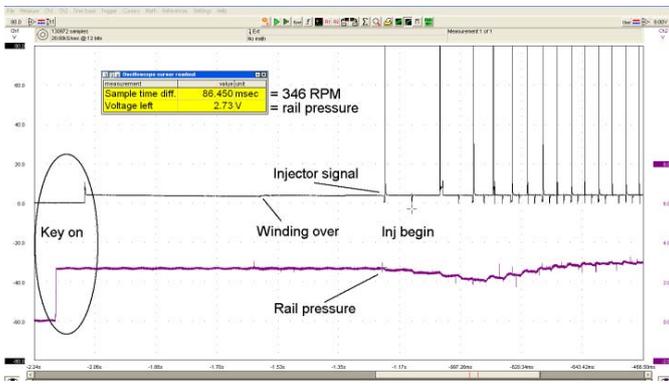
We needed to check. A recording of fuel pressure vs. injectors was made. It showed that the injectors get actuated immediately upon winding over of the engine, with or without pressure.

Picture 1: 2 Channel ATS recording of injection vs. Injector rail pressure.

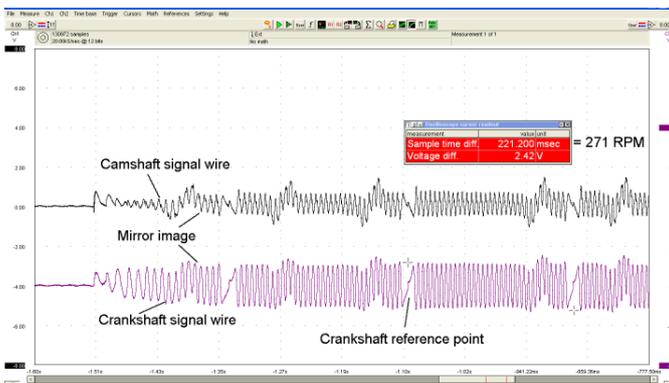
PICTURE 2 : ATS 5000 scope recording of faulty Cam vs. Crank sensor signal while engine refuses to start. Both patterns are almost each other's mirror image.

From the help desk we told the diagnostician that the patterns could not be each other's mirror image! The cam has to be different from the crank signal. Also the signal was not steady in height. The combination of these remarks made the AECS support person query if the scope's earth lead was properly connected to the battery negative (!) or that the earth lead was perhaps connected to a bad earth like for example the engine block.

This could only mean one thing; the shared earth of the inductive sensors was disconnected. Many vehicles have their inductive sensors connected floating, but not on Toyota.

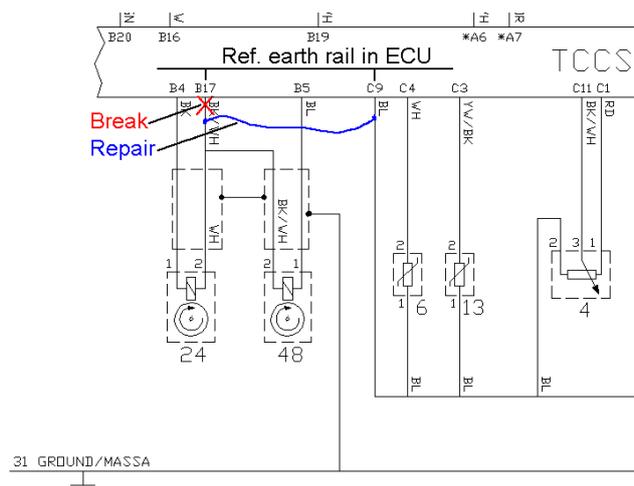
Closer inspection of the wiring loom and ECU connector showed that the pin in the ECU connector was damaged most likely caused by someone back probing the pin at some stage. The pins are so small and fragile that remove/repair was not really an option. A permanent jumper wire was fitted from the cam/crank shaft earth to the TPS earth close to the ECU, as a lasting fix.

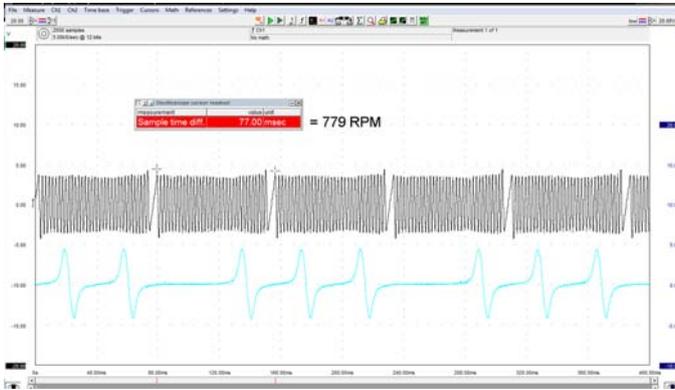
PICTURE 4: Recorded scope pattern of Cam (Ch2) and crank (Ch1) sensor signals with fixed earth.

The car is in good condition now and running how it should.

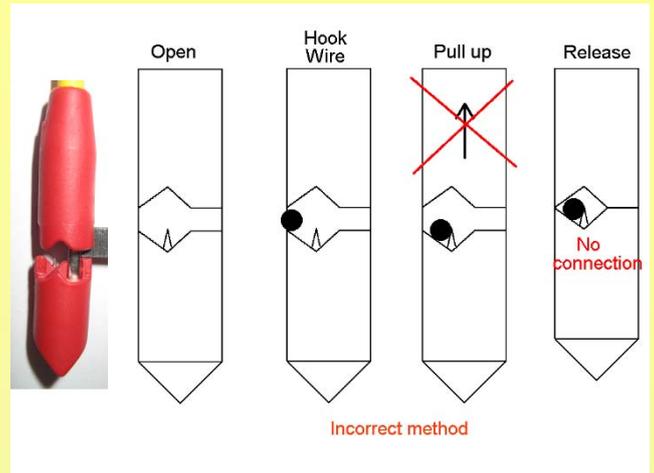
Many users of measurement equipment are using the piercing Hirschmann probes incorrectly. They get irritated by their unreliability. See the picture below, can you see what the problem can be?
