Wizard Wise

This article is a true description of an AECS technical help desk problem and how it was solved.

2002 Isuzu Wizard 3.2 V6 petrol (drive by wire)

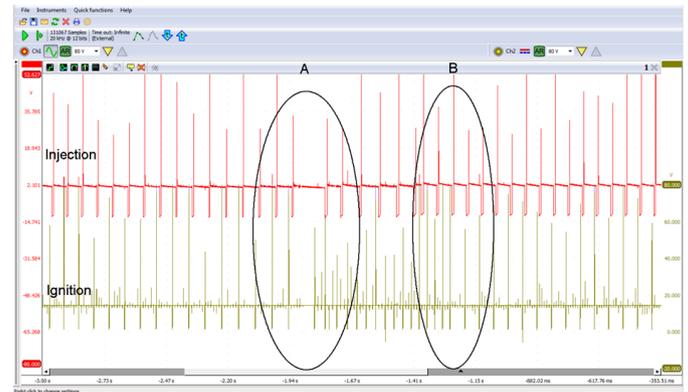
ATIS 5000 scope recording of ignition vs. injection.

Two spots in the pattern show irregularities, they need further investigation. Please find below the same pattern zoomed in.

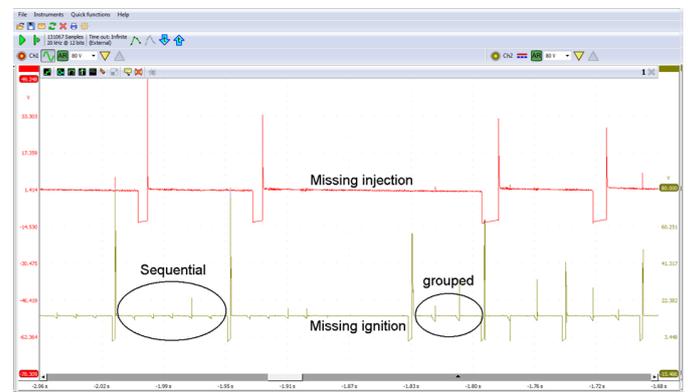
Zoomed in pattern of Ignition vs injection

Firstly, there is an irregularity in the injection pattern; there is a pulse missing, and just after the missing pulse are broader injection pulses.

Secondly the ignition pattern; I have circled the area between the ignition pulses, where 5 dips are visible between the two ignition patterns. These dips are the result of a shared bad power supply by all coils. The bad power supply is not the problem. It does indicate that there are 6 separate coils firing sequentially, each coil firing every 720 crankshaft degrees.

After the missing ignition, there are only 2 dips between the ignition patterns. This indicates that the ECU switches to semi sequential (grouped) ignition, each coil firing every 360-crankshaft degrees. The dips are deeper in this section, indicating that the current draw on the bad power supply is higher, so it is safe to assume that two coils fire at the same time (grouped).

The missing pulses in both patterns will make the car stumble, as for about two revolutions there is no ignition and no injection. This is the moment when the car was driven over the bump in the road.

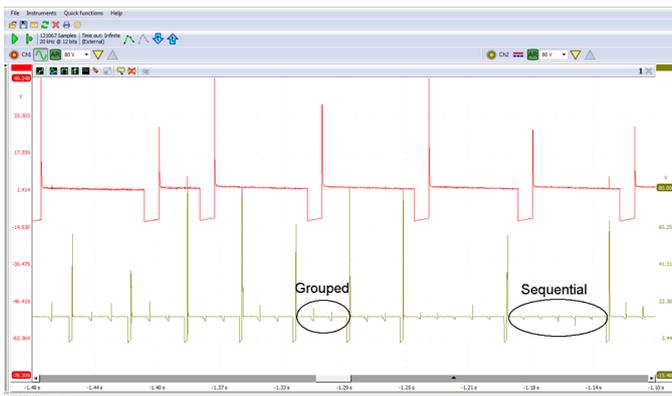
Zoomed in on section B, the ignition and injection return to sequential again

In the previous pattern, both the ignition and injection return seamlessly back to sequential again, this will not be noticed during driving.

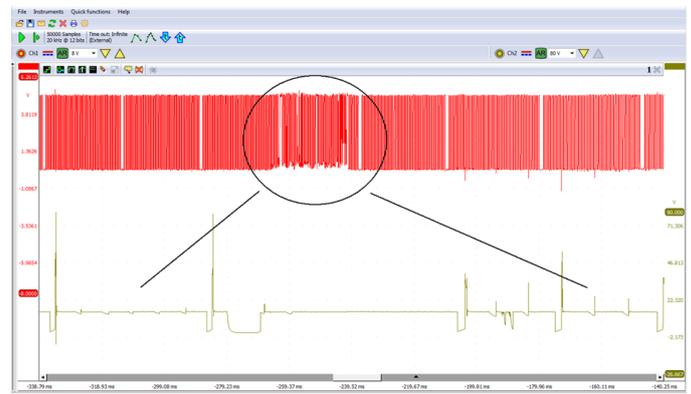
In the above pattern, recorded while driving over a bump, the crankshaft sensor signal (CH1) is clearly interrupted at the moment when the ignition (CH2) changes from sequential to semi sequential.

Please note: *there are big dips in the ignition pattern, which I blame on the connection between the scope probe, and signal wire, being interrupted while the driving over the bump.*

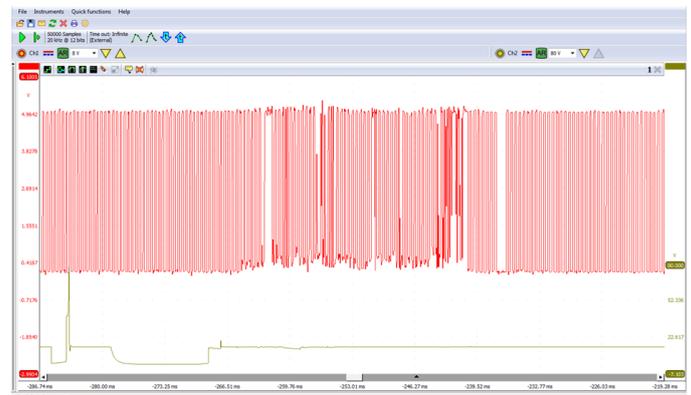
Zoomed in on crankshaft disruption.

The above zoomed pattern shows the crankshaft sensor signal going all wrong. This eliminates the ECU and the ECU power supply as possible faults, as mentioned before.

The diagnostician decided to draw an extra heavy earth wire to the connection point on the intake manifold. This had hardly an effect, but an effect all the same!

After consultation with the AECS help desk, he decided to split the high current wire for the throttle control motor circuit of the three and leave it connected to the manifold due to its high speed current changes putting interference on every earth point. The throttle motor earth was found while measuring with a current clamp on that wire.

The other ECU earth wires were all directly connected to the new earth cable without being connected to the manifold.

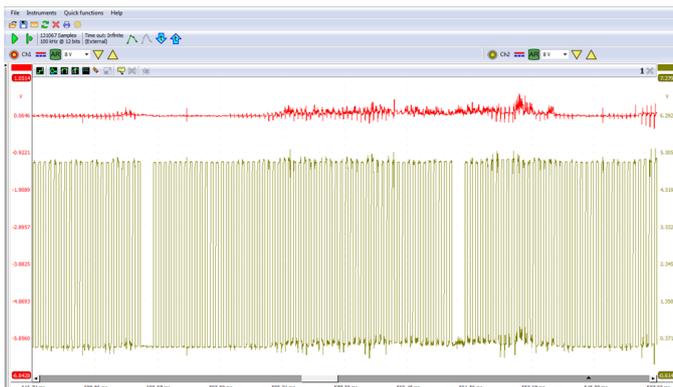
Zoomed in recording of ECU earth vs Crankshaft.

The ECU earth still shows signs of the throttle control motor loading up the earths while the throttle position changes (correction) while driving over the bump, however the crank shaft signal voltage does not lift up nearly as much as what it did in the previous recording. It easily passed the 'arm' and 'fire' points in the ECU. The original wires were connected to the ECU and hall sensor again, with no effect on the signal.

We were not happy with the signal, it is not clean, but short of redesigning the car, economically we could not do much more to rectify this problem.
