Munted Mondeo

This article is a true description of an AECS technical help desk problem and how it was solved.

2008 Ford Mondeo 2.0L common rail Diesel turbo.

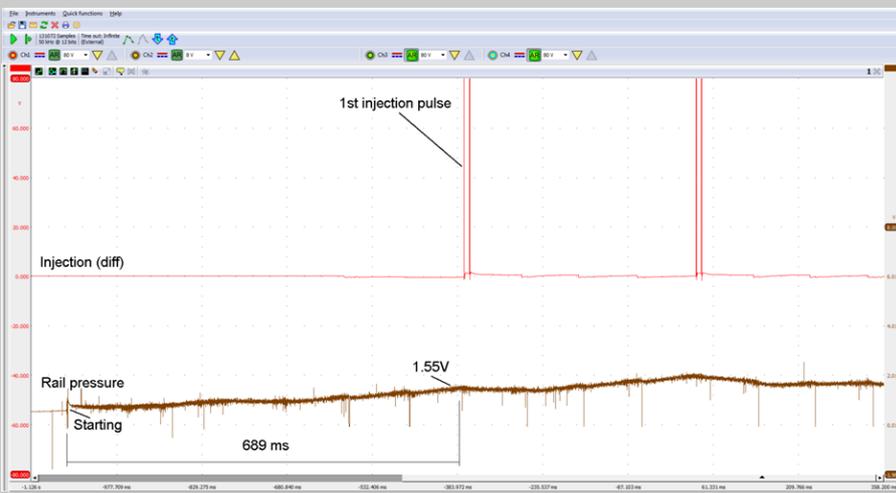
The ATS scope recording looked all normal! (picture1) After about 2/3rd of a second the rail pressure is high enough to allow injection. Please note that injection does not take place when the rail pressure is not high enough.

Picture 1: ATS scope recording Injection vs rail pressure.

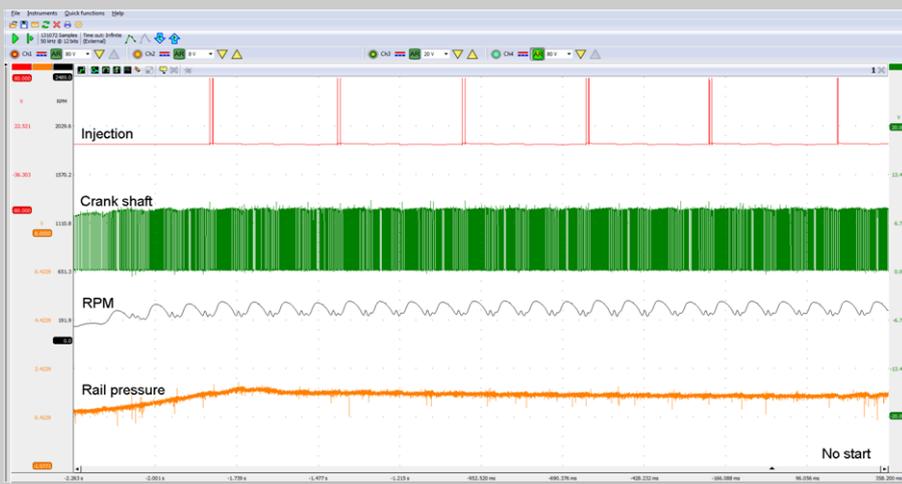
A recording of the rail pressure, injection and crank shaft sensor was made. (picture 2) The crank shaft sensor signal was trans-

formed in an analogue RPM signal, showing the crankshaft speed fluctuations as a result of compression/decompression.

Picture 2: ATS 5004 3 channel recording with added RPM trace for TDC

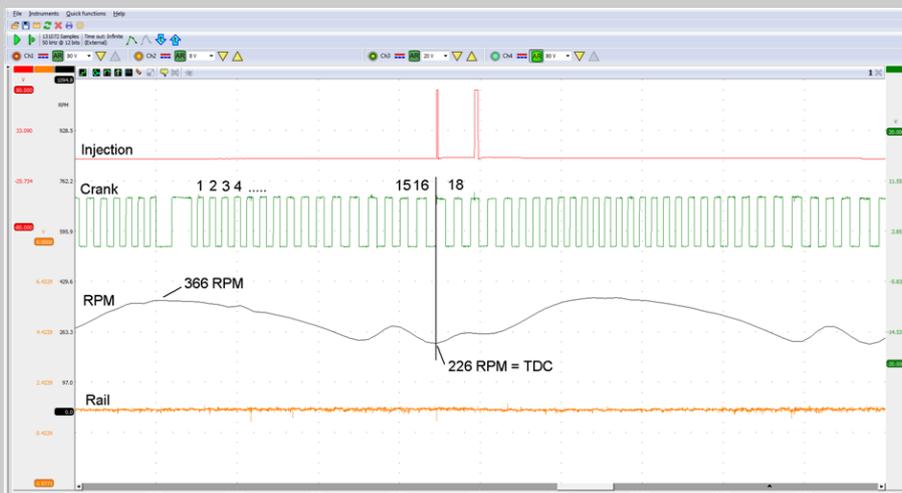
From the recording in picture 3

is clearly visible that the injector fires at around TDC (slowest crank speed), which is normal for a common rail low compression engine while turning slow.

So according to this recording the timing was correct, or was it?

Picture 3: ATS recording zoomed in for timing check, non-start car

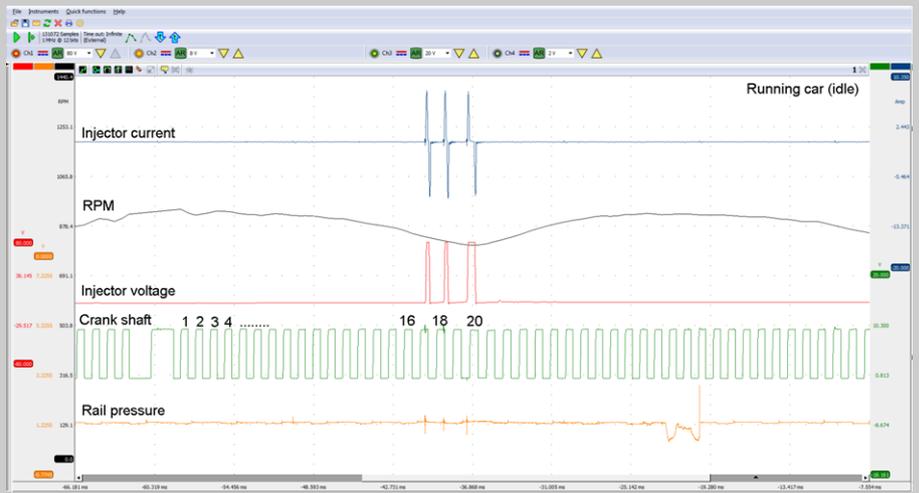
going car. (picture 4)

This showed clearly that the injector fired at approximately the same spot on the crank shaft as the non-starting car. We were sure now that the timing was very close to correct, to at least make a sound and smoke.

Picture 4: ATS recording for timing check, good car.

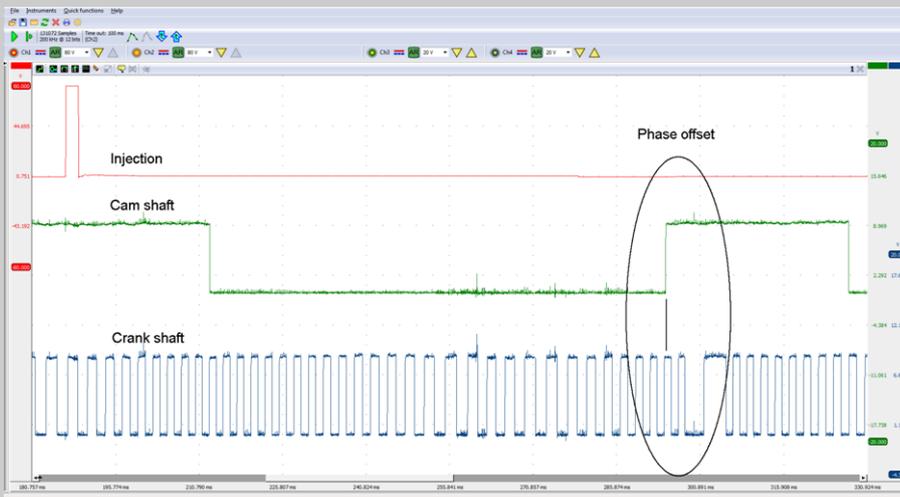
Picture 5 :Cam crank relation recording on non-starting vehicle

The phase difference is a bit more than 3 teeth on the tone wheel. On the circumference of the tone wheel are 58 teeth and 2 missing teeth. This makes that from teeth to teeth the crank shaft has rotated 6 degrees. In crank angle degrees is 3 teeth 18 degrees. That is equal to one having the timing belt on the crank shaft sprocket 1 tooth out.

In the pattern in picture 5, the injection pattern visible, yet the engine does not start. Please note the phase offset between the cam and crank.

The timing belt was redone and the car started perfectly (after connecting the injectors correctly back up again).

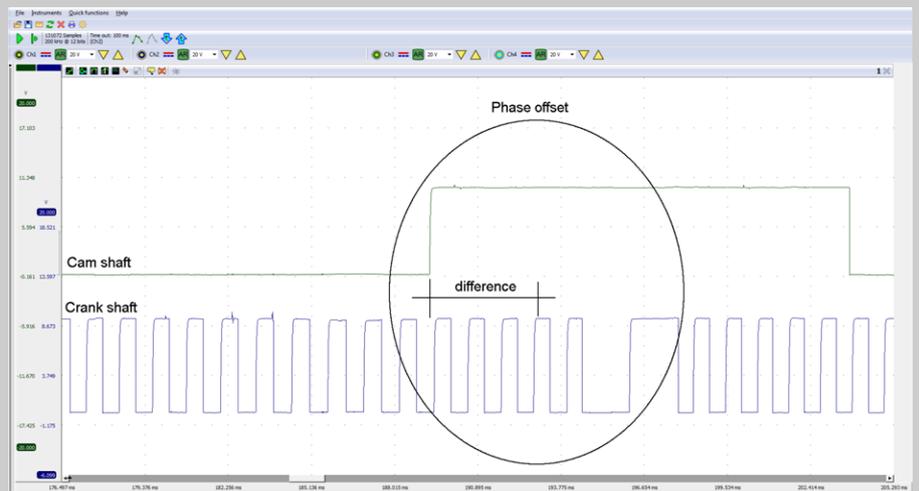
The next pattern in picture 6 is recorded on the running identical vehicle. Please note the phase offset between the cam and crank and compare it with the not going vehicle.

Picture 6: ATS scope recording cam and crank on going vehicle.
