Bizarre XR

This article is a true description of an AECS technical help desk problem and how it was solved.

2003 Ford 5.4L 260kw Boss XR8.

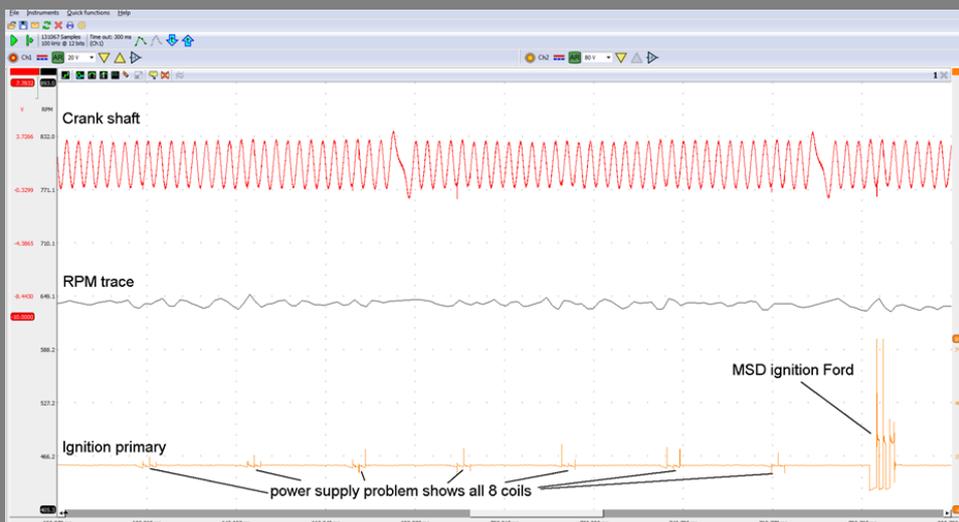
Picture 1:
The ATS5000 2 channel scope recording shows crank shaft sensor vs Ignition primary, and a calculated RPM trace.

The above RPM trace shows to us, despite lots of vertical zoom, indeed virtually no RPM fluctuations as a result of compression and ignition on the RPM trace. The scope owner incorrectly blames the spacing of the tone wheel teeth. At the end of this article, it will become clear why there is no Delta-N visible.... (Hindsight is easy).

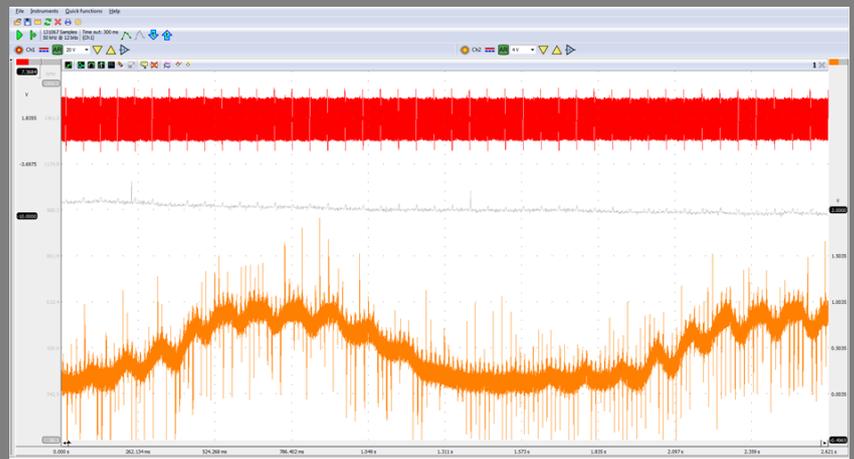
Because the Fuel trims are so different between the left and RH bank the technician has recorded the crank shaft vs oxygen sensor (picture 2), to see if any misfire became apparent.

Picture 2: ATS recording of crank (plus RPM trace) and oxygen sensor.

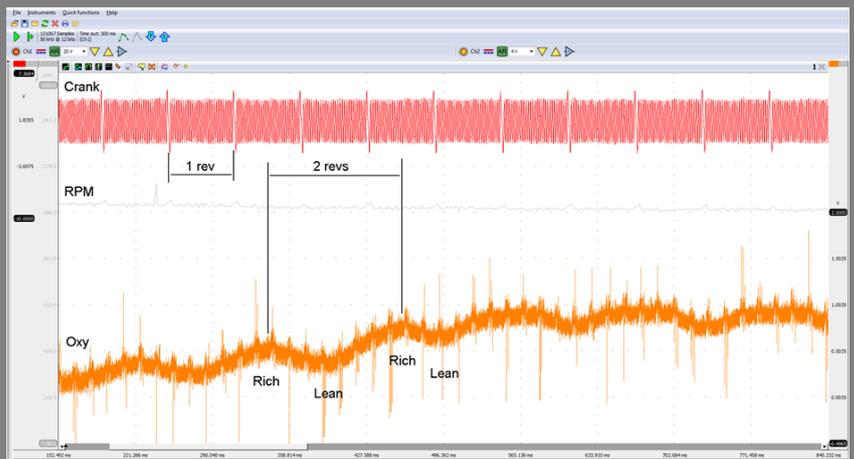
The recording of the oxygen sensor in picture 3 shows dips when it moves from lean to rich (from low to high). Zoomed in, it becomes clearer that only one bank is at fault.

During the cycling of the oxygen sensor, it is clear that every second revolution of the engine the mixture bias moves to leaner than intended. This explains why the fuel trim of one bank only was off. Could this mean that one bank had a lower fuel pressure...? No the injectors are all connected to the same fuel line. It had to be something wrong with the engine itself or the ignition system on one bank. The car has eight coils, all were tested with the scope and showed nothing wrong.

Picture 3: Zoomed in on crank vs oxy.

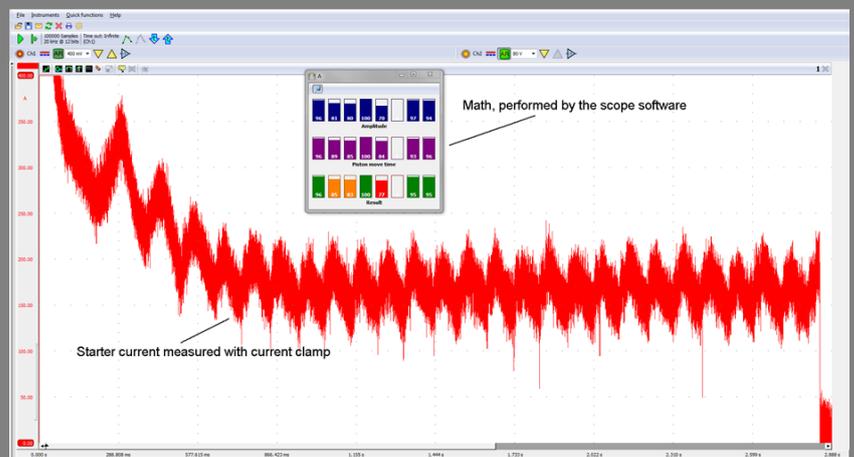
The next stage was to look at the engine and see if perhaps there was a mechanical issue. The easiest place to start is to do a compression test as in Picture 4. With the scope, a relative compression test can be performed in about 30 seconds or so.

The relative compression test showed that definitely something was wrong with 4 cylinders. BTW, this test is *not* providing you with an

Picture 4: ATS scope relative compression test.

answer about "what is wrong" with which cylinder, it just shows that there is something wrong and that a pressure test needs to be performed.

The compression pressure tester showed the following (in old fashioned PSI...):

RHS bank (driver's side)

- 1-170
- 2-162
- 3-168
- 4-170

LHS (passenger's side)

- 5-149
- 6-150
- 7-151
- 8-155

The test clearly shows that there is an engine issue.

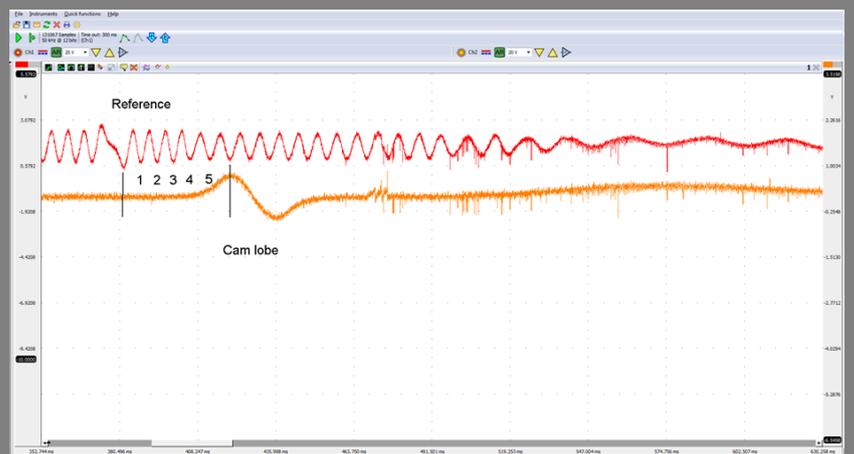
Picture 5: Winding over

Time to look at crank and cam signals! A recording was made during starting. In picture 5 & 6 we have zoomed in on two spots of the same

Look at the scroll bar in the bottom of the pattern and see the time progression of the recording. Also, please look at the timing shift of the cam shaft in relation to the crank shaft (more than 10 crank degrees). This indicates to me immediately chain lash, or a loose tone wheel or something else mechanical. We deal with these issues in several AECS training seminars.

The technician pulled front of the engine. He found the crank pulley bolt was finger tight, the trigger wheel has been chattering on the crank keyway and now has about 1 1/2 teeth slop. This explains the scope patterns!

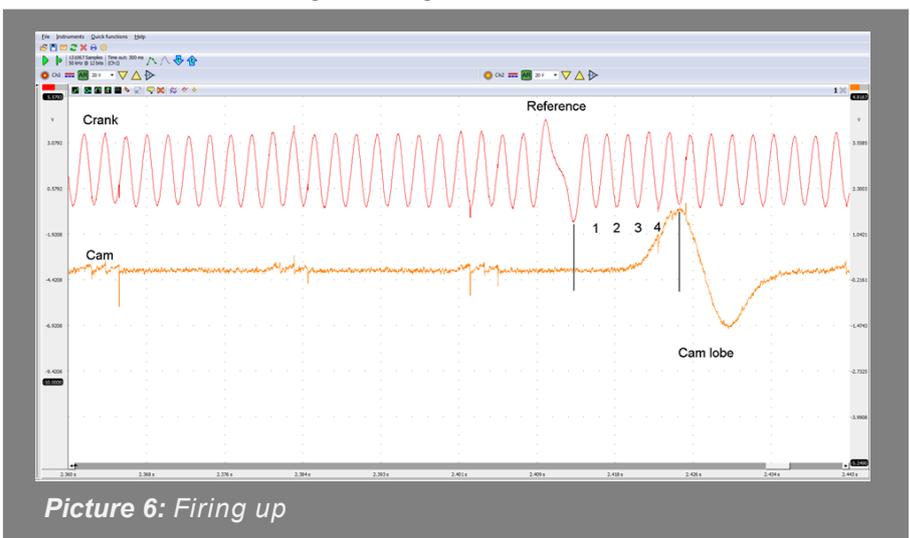
Picture 6: Firing up

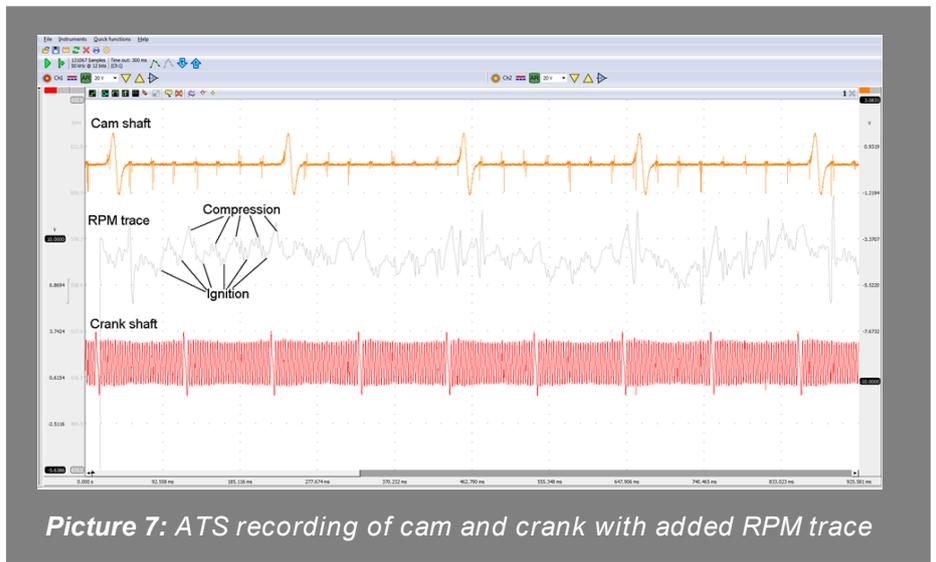
The cam and crank are continuous in perfect sync, also the crankshaft sensor signal shows "Delta-N" compression and ignition RPM changes) again!
Even Long Term Fuel Trims are equal between banks.

Picture 7: ATS recording of cam and crank with added RPM trace

The technician replaced all front sprockets, chains, guide tensioners and recorded the following pattern as shown in Picture 7:
