Exhausted E-class

*This article is a true description of an **AECS** technical help desk problem and how it was solved.*

2003 Mercedes Benz E-class 3.2Ltr Bosch CP3 CR diesel.

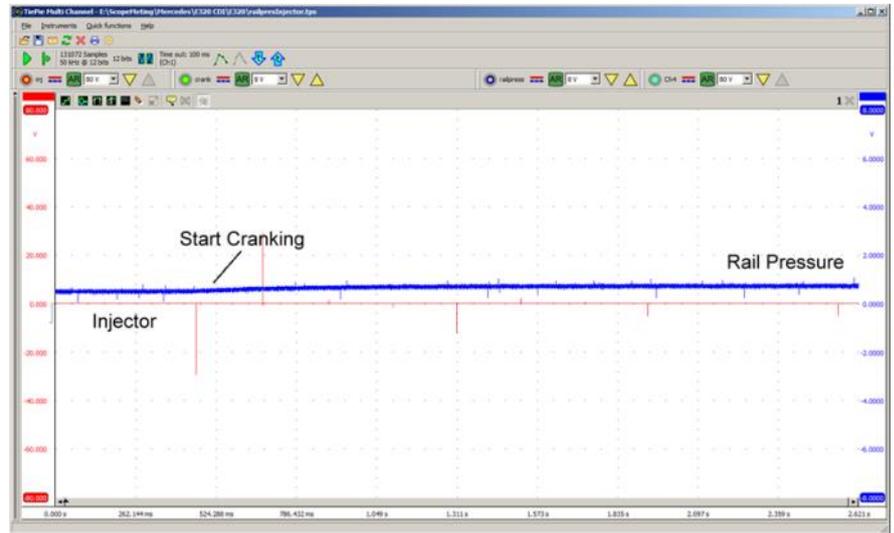
Figure 1: Injection vs Rail Pressure during cranking

In Figure 1, we can see that there is no injection occurring while cranking. What are the possible causes?

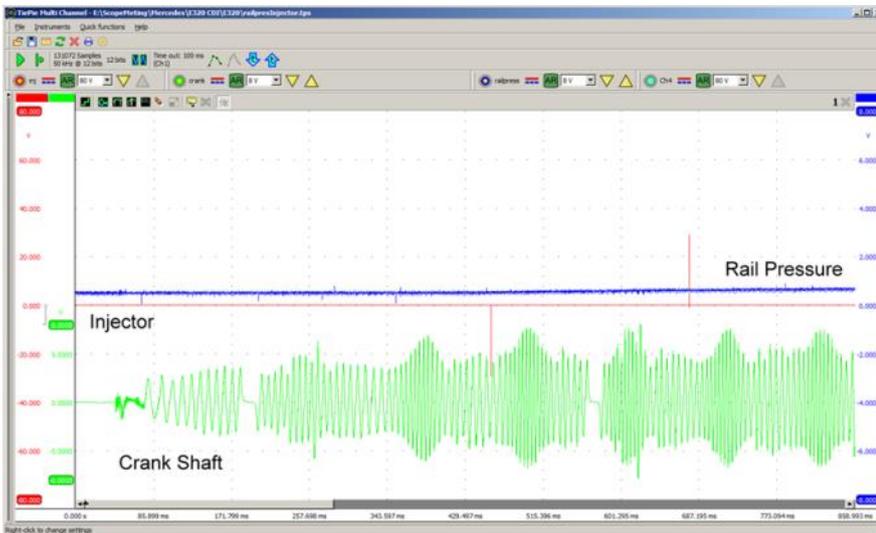
Figure 2: Injector, Rail Pressure and Crankshaft sensor

The ATS5004D is the first scope the diagnostician uses because with four channels he can see more. The recording in figure 2 shows injection with rail pressure and crankshaft sensor output measured at the ECU. We can see from the crank shaft sensor output voltage height, that it easily exceeds the ARM and FIRE points inside the ECU (as discussed in the AED training). Therefore, our issue is not with the crankshaft sensor.

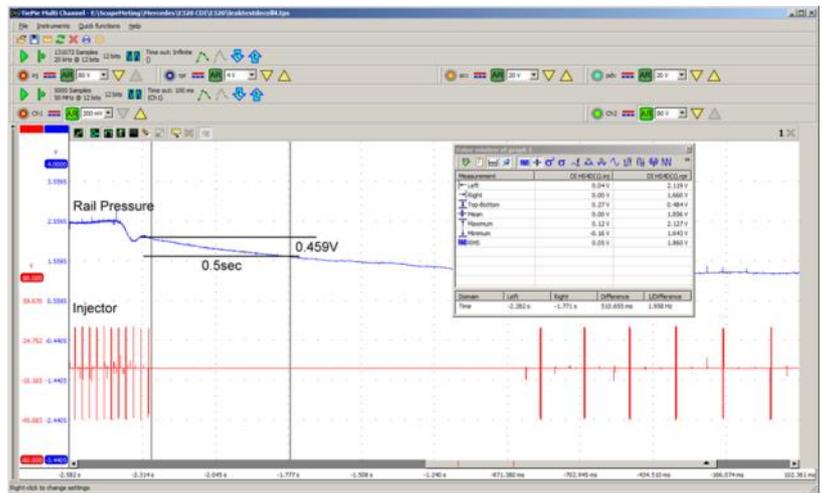
Figure 3: Rail Pressure Leakage measured under deceleration fuel cut

Figure 3 shows a drop in rail pressure of 0.459 V in 0.5 seconds during deceleration fuel cut. DMS1-3 training seminar knowledge tells us that this is approximately 2.5 times an acceptable level of leakage on a Denso common rail system.

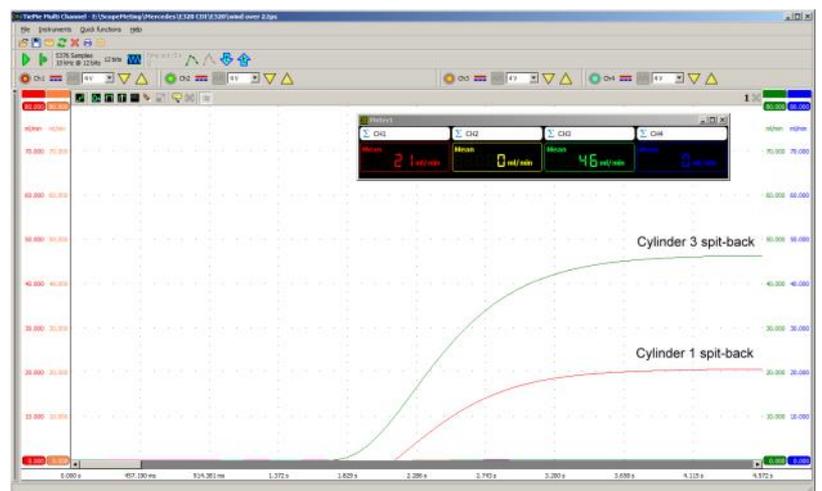
Figure 5: return flow on first four injectors showing high spit-back on injectors 1 and 3

Figure 5 shows the return flow measurement during cranking (not firing up).

We have found out why the high pressure rail pressure remains too low for injector activity. When the injectors do not get activated, the return flow should be zero. Two injectors show 21 and 46 ml/min return flow during cranking! That fuel does not stay in the rail...

Due to the high mileage of the vehicle and previously unknown service history, it was decided to fit 6 remanufactured injectors. Winding over (after bleeding the system and letting the vehicle glow) it started within a few beats. This is the point at which most workshops wrap up the job and send it out the door. Luckily, the technician was convinced to recheck one measurement. Remember Figure 3 shows the deceleration rail leakage

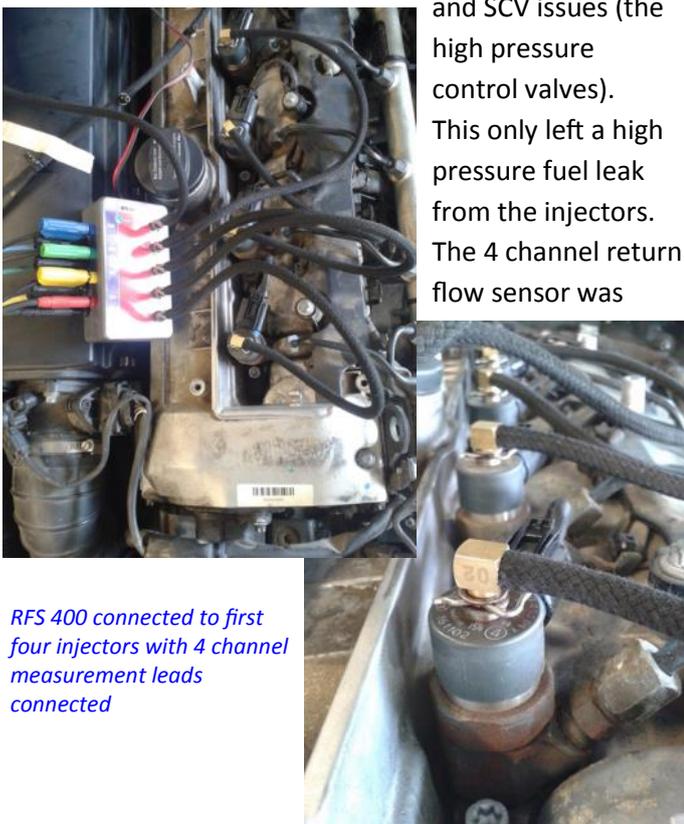
connected to the first four injector return lines to check injector leak back as in Figure 4. We know that during winding over and not firing up, there is no injector activation.

RFS 400 connected to first four injectors with 4 channel measurement leads connected

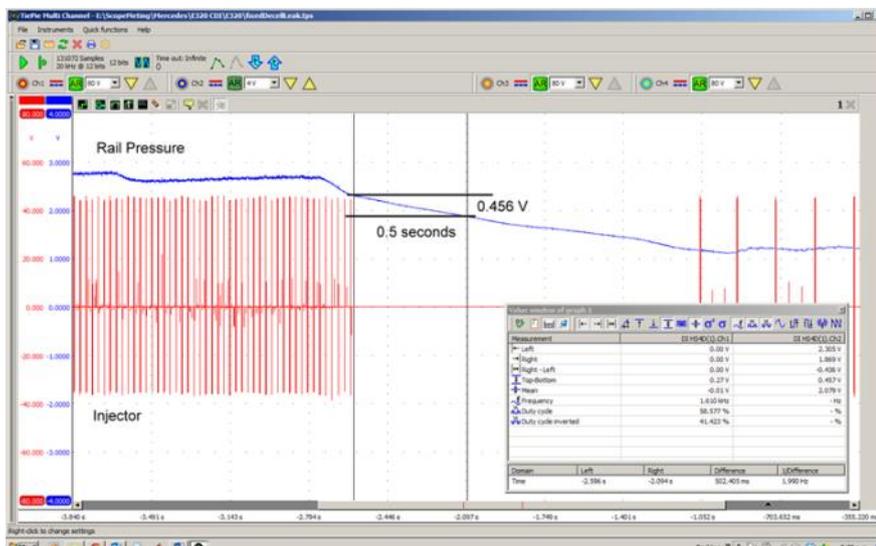
Figure 6: Deceleration leakage with 6 re-manufactured injectors.

with the “bad” injectors. Figure 6 shows the same measurement with the remanufactured injectors. Also in Figure 6, it still shows that we have a high leak rate compared to the Denso reference. Mmm... It turns out that this CP3 system has got closed loop pressure control under deceleration and that there is a difference in the duty-cycle control of the pressure dump valve during deceleration, which is covered in detailed in our DMS1-3 training.
