Injection Rejection

2007 VW Golf 1.4 BLG 4cyl TSI petrol engine direct injection.

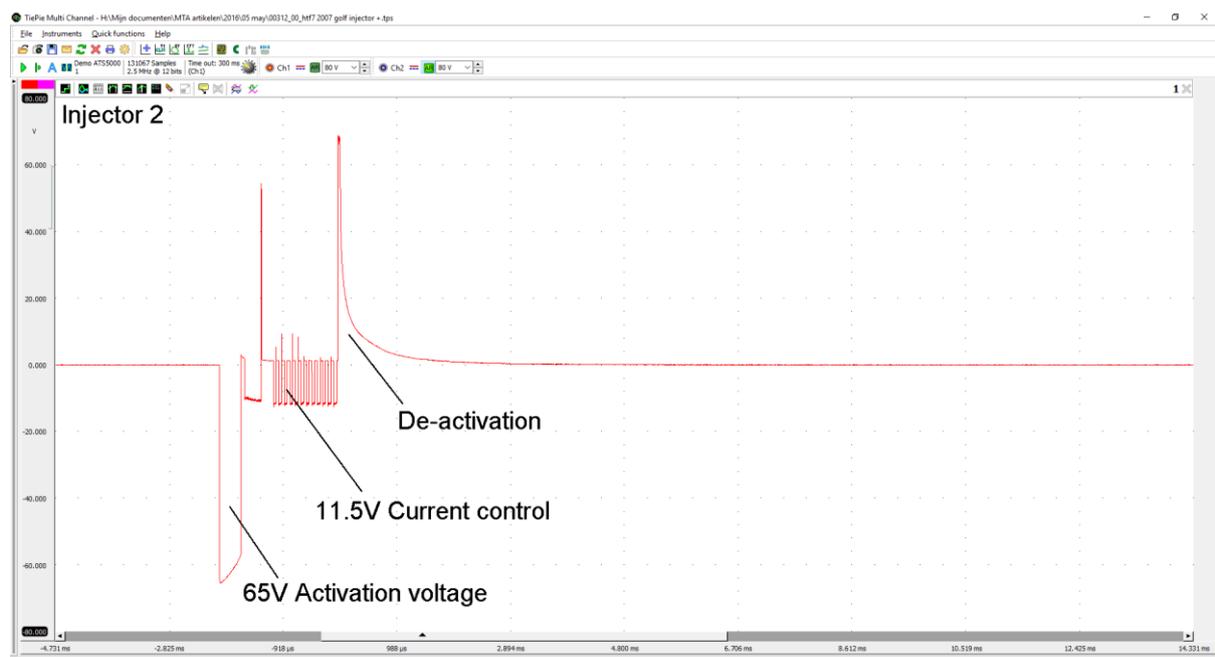
ATS 5004 differential measurement of injector 2.

On injector 2 it is clear to see that the ECU opens the injector with 65V, and then enters injector hold by switching between 11.5V and earth.

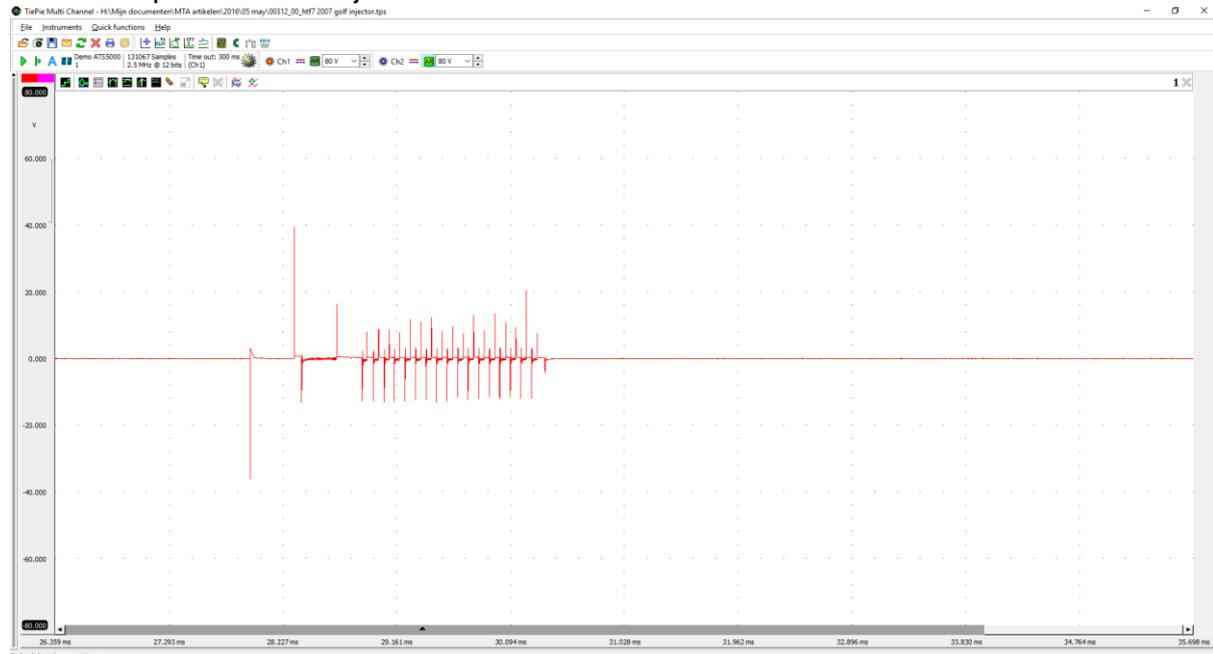
ATS 5004 differential recording of injector 3.

There is no voltage difference across the injector 3, indicating that the ECU does not switch the injector on the earth side, but that it does switch it on the power supply/ current control side. That surely indicates an ECU fault correct?

Well in our view it could also be an open loop inside the injector or between the injector and the ECU on the earth side. We advised not to replace the ECU just yet.

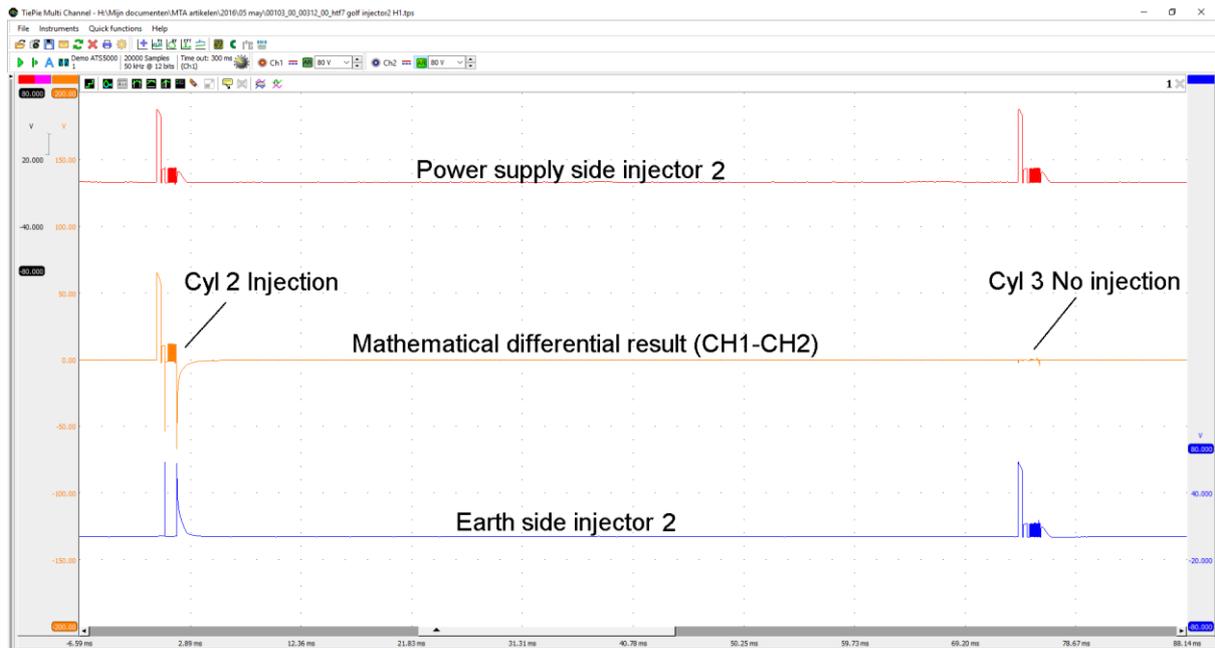
We also asked him to record off set, with 1 channel on each side of the injector. In the below recorded pattern you can see a recording done on injector 3, the pattern recorded on injector 2 was identical!!!

ATS scope recording on both wires of injector 2. The differential line is a product of the live math function of the scope and shows if the injector is activated or not (live).

We had injection on all injectors (including 2 and 3) for the first time, what happened?

- The ECU was fully able to 'drive' the injector at cylinder 3, concluding that the injector driver inside the ECU was not broken. Confirming that ECU replacement was not necessary!
- The ECU deliberately did not activate the injector, as a direct result of the misfire detected (P0303) fault code, to protect the catalytic converter.

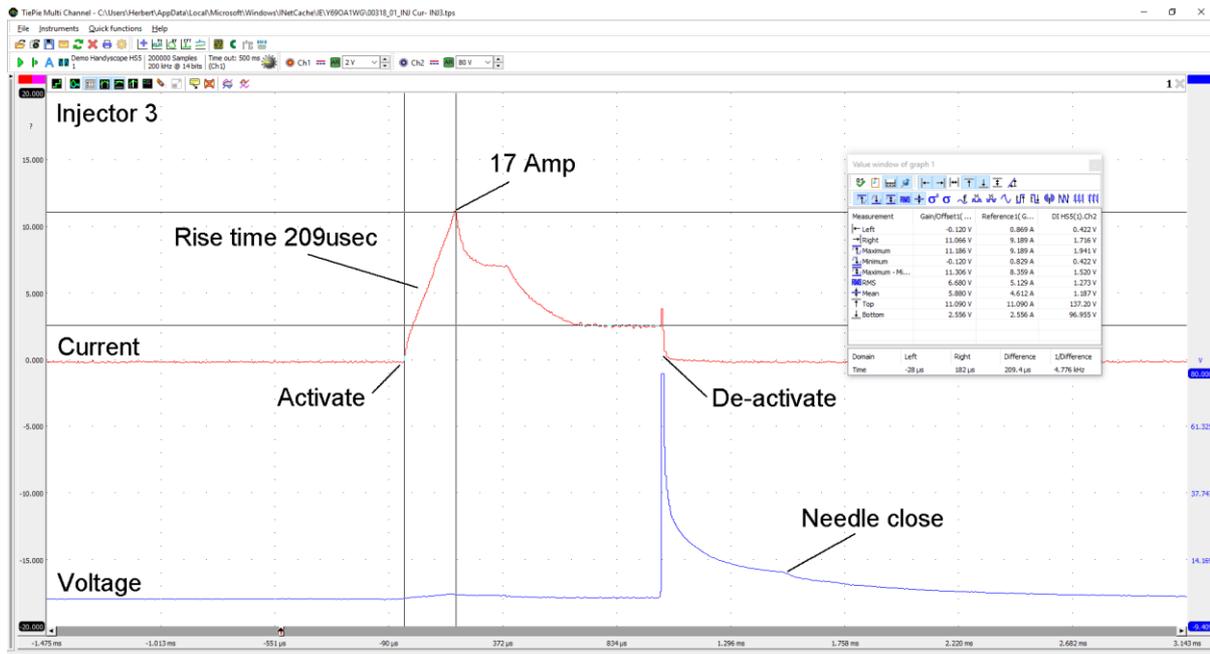
In the pattern below we measured the peak current after activation and the rise time for the current to reach the peak. If a short or bad connection was present, this rise time would be affected.

The peak current and rise time of all injectors was identical. That sorted the injector circuit. Our comment was that the ECU was most likely good and that the injector was most likely good, and that the problem might simply be an ignition problem. We needed to see the ignition pattern!

ATS recording of voltage vs current measurement injector 3

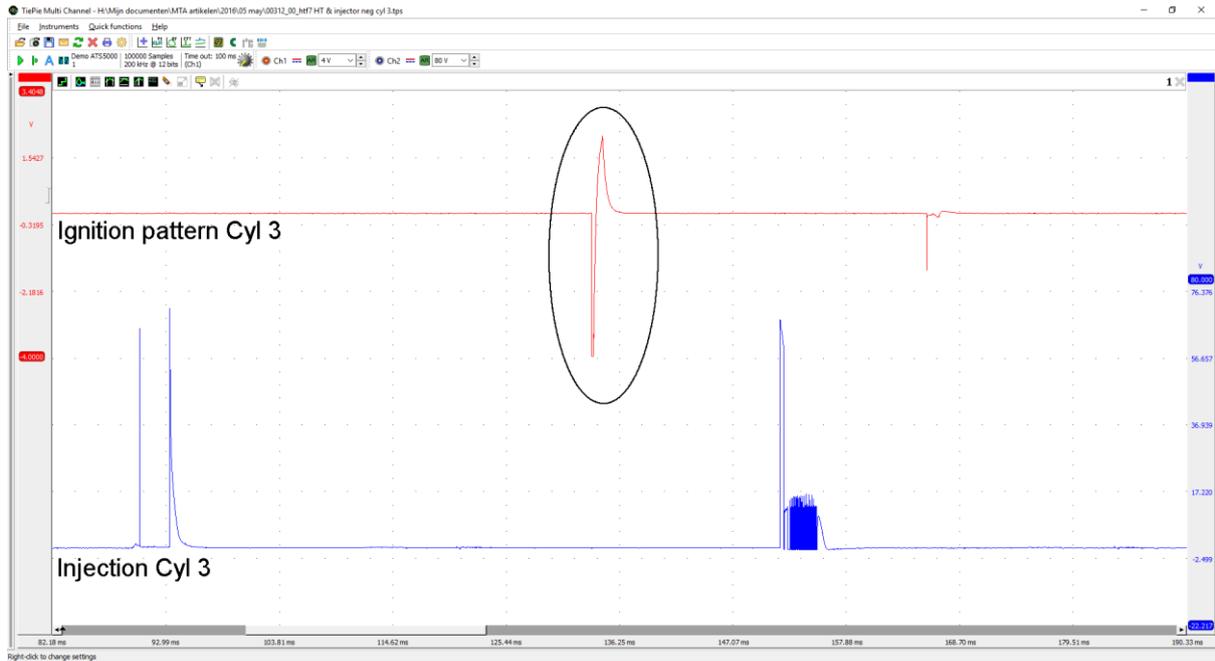
ATS scope recording induced ignition and injection on cylinder 3.

The ignition and injection pattern revealed a very strange ignition pattern, we might be onto it but had to check the pattern with a good cylinder's coil.

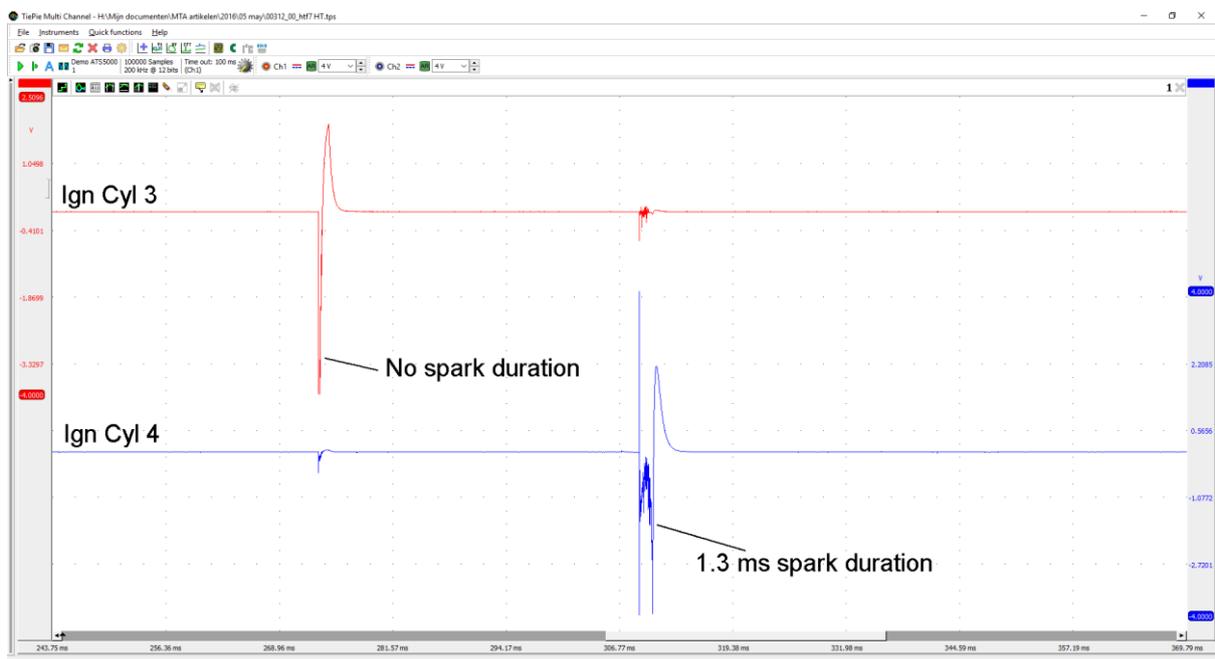
ATS scope recording of 2 induced ignition patterns.

Yes that IS the problem! No ignition (no spark duration) on cylinder 3, that is surely why the cylinder misfire detected fault code comes from and why the injector was shut down!

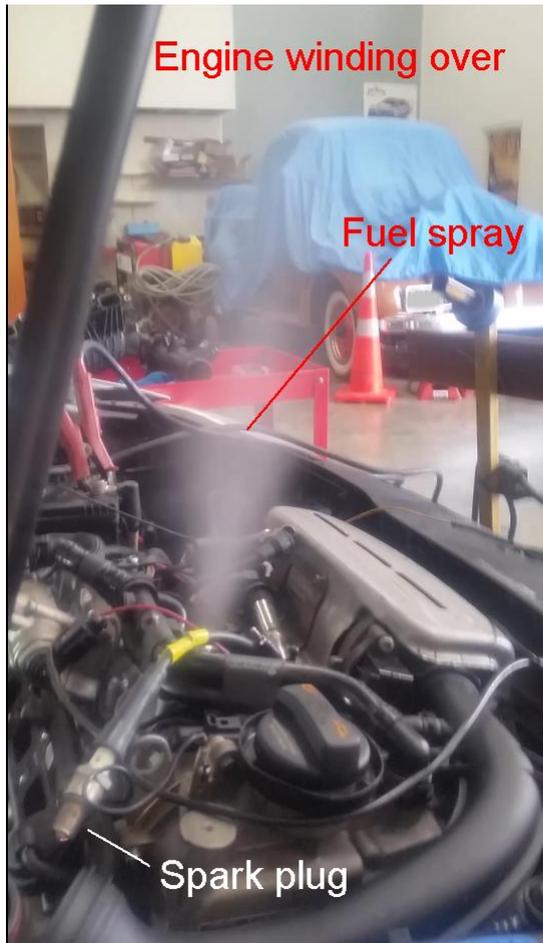
Screen shot of the movie sent to us.

He took the effort of recording what happened next on his phone and emailed us the movie.... I have never seen so much fuel coming out of a combustion chamber!! Nice little detail on the video is the connected and arcing sparkplug ☺.

Okay that was a perfect indication why the spark duration on cylinder #3 was 0 msec. The flood of petrol pouring in from the crook injector number 3 drowned the plug, causing the high tension to track straight to earth, causing a misfire logging code P0303.

The injector was electronically okay but mechanically it stayed open.
