# STUBBORN STABILITY CONTROL

VEHICLE: TOYOTA PRIUS 2ZR-FXE HYBRID 2012

This diagnostic article takes you through the process our technical support team use with problematic vehicles. We look at the issues involved and share how we resolved the problem. This an inside look, from the profound to everyday issues automotive workshops encounter.

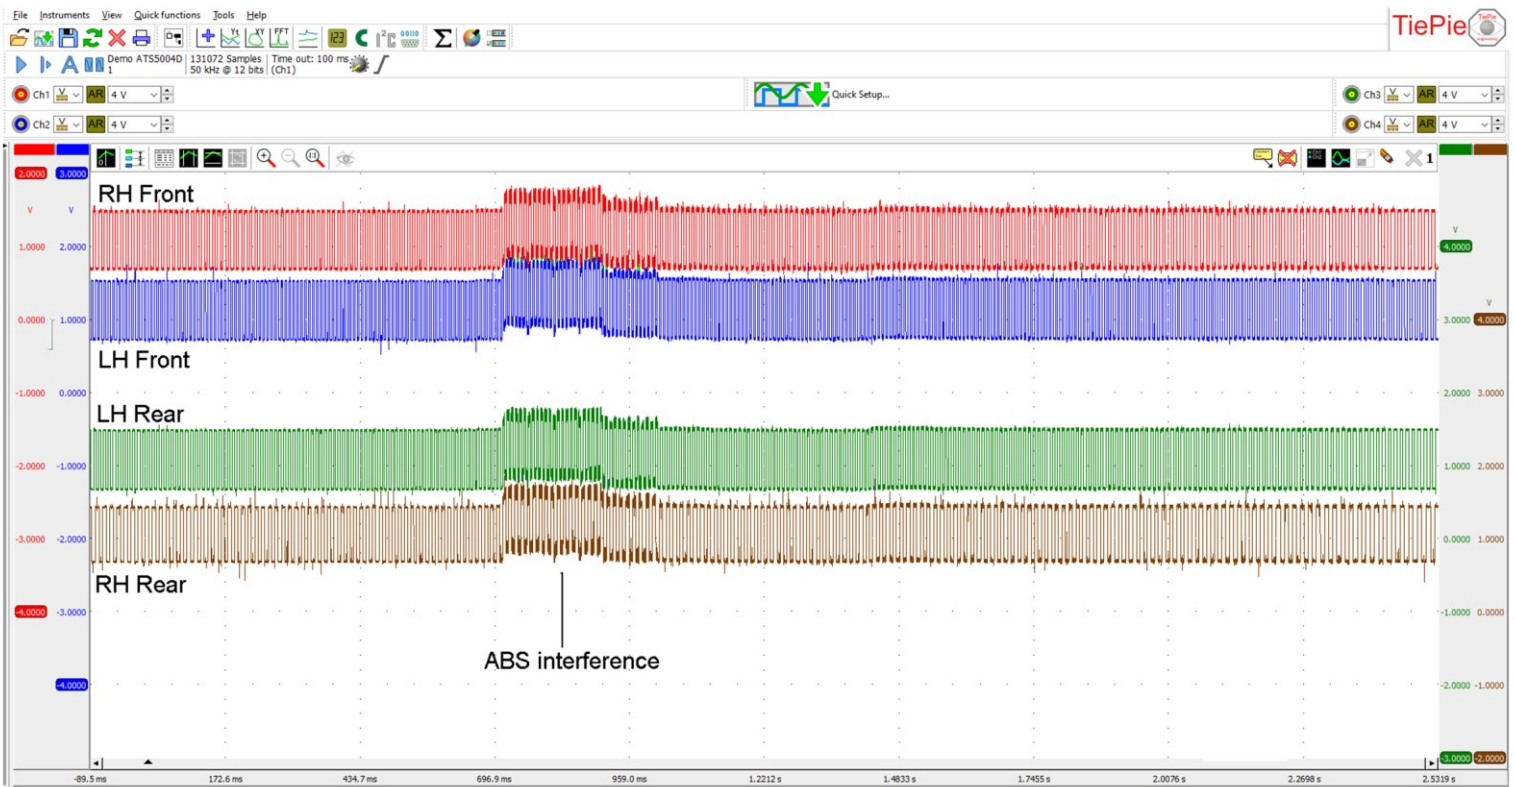
**ATS scope recording made while cornering when the stability control function of the ABS changed the car's direction unintended.**

The first thing that springs to mind in this recording is that there is an earth problem in the ABS unit. All signals' voltage lifts up when the ABS pump motor and valves are powered up. However, the sensors used are current proxy switches. The signals produced by these sensors are not measured by voltage, the current through the sensor is measured by the ABS processor, the change in voltage does therefore have virtually no effect on the signal. In the AECS Modern Anti-Theft Systems (EMS1-5) training course we deal with these sensors in great detail, knowledge equals reduced costly & unnecessary repairs.

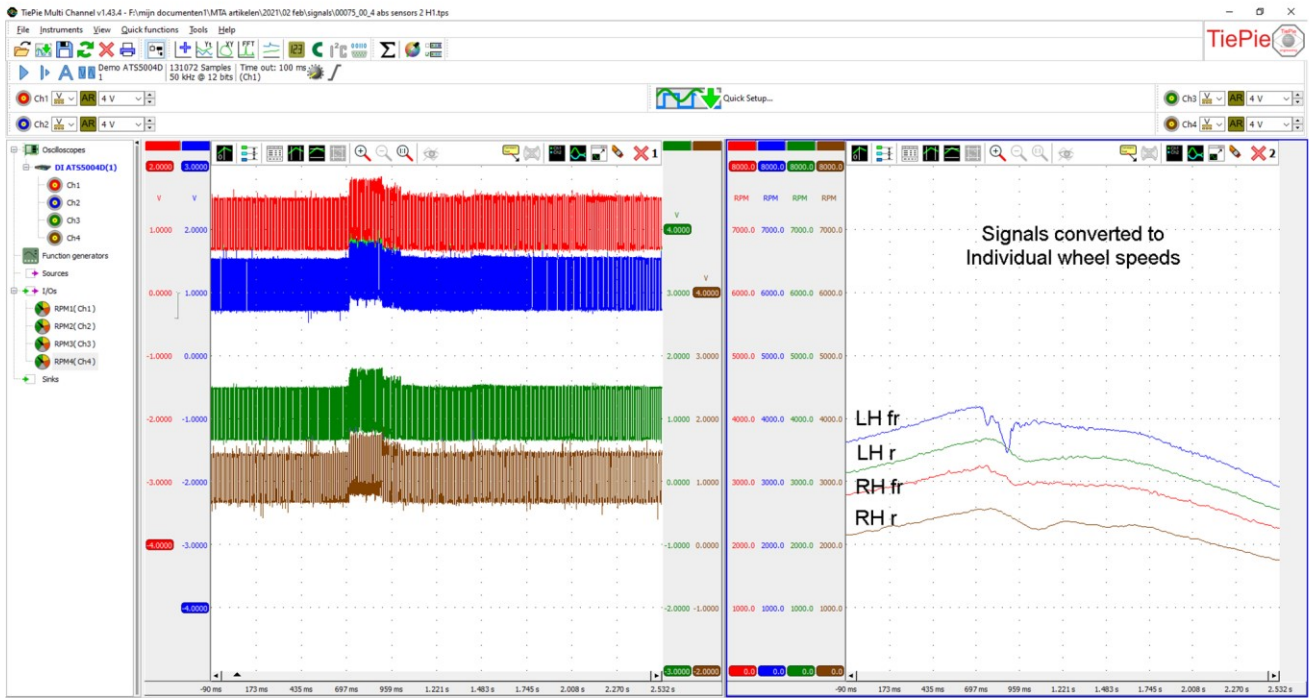
The signals of the 4 wheel speed sensors have been converted into 4 individual wheel speed traces.

This makes more sense already! In the above speed recording, it is clearly visible that the LH front wheel is being braked during cornering. It is also visible that the car is cornering to the right as the wheel speeds on the left are greater than the RH wheel speeds. Let's play with this some more.

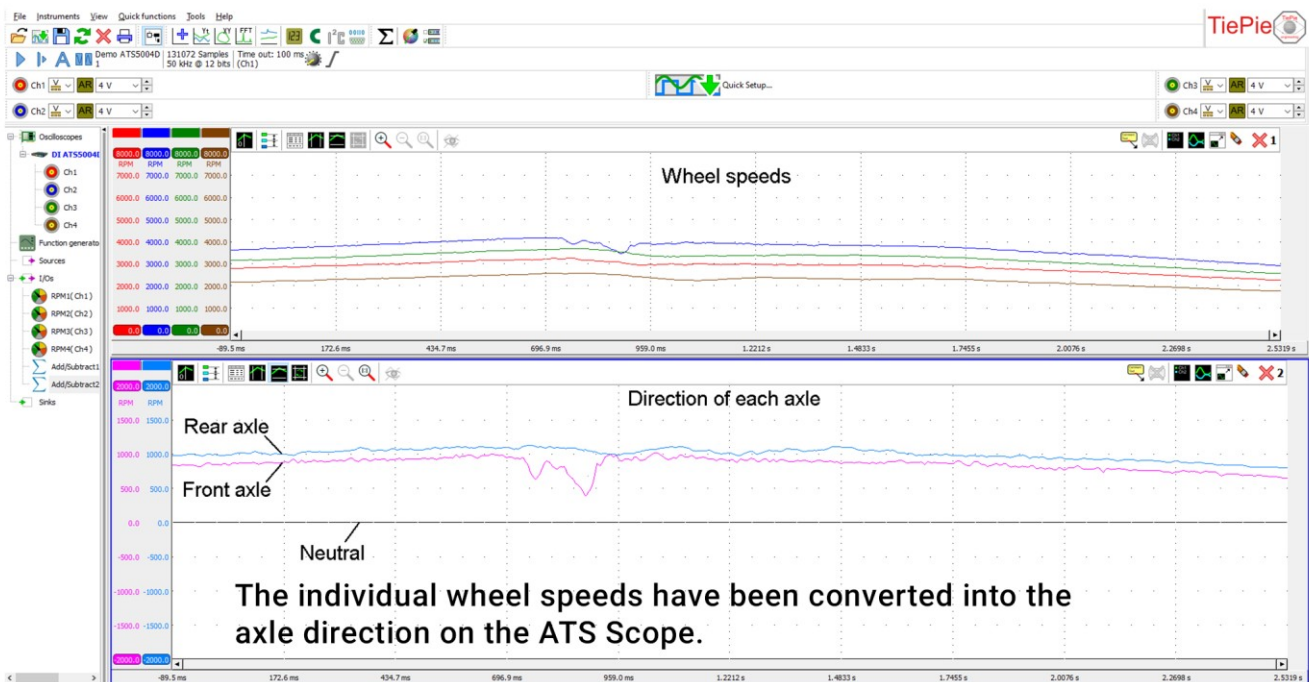
The individual wheel speeds have been converted into the axle direction on the ATS Scope.

Okay now, this is what should make sense to any (automotive) technician's mind, 'in which direction are the individual axles going'. The rear axle is logically always turning a tighter corner, so its direction (the blue line) is further away from being straight ahead (the black Neutral line).

In my mind, it is clear that the stability control judges that the front axle is turning too tight into the right-hand corner based on the front wheel speeds, and it doesn't like it, so it pulls the brakes on the left front wheel. How would you make such a reaction visible with any other tool?

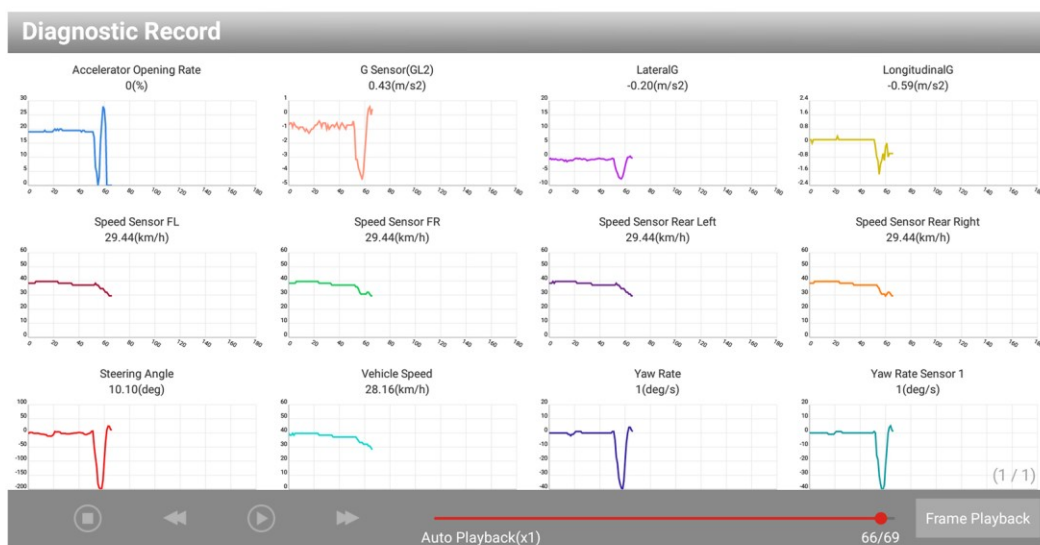
Launch Scan Tool recording of the badly behaving car.

At frame 58 the steering wheel is turned to a  $-196^\circ$  angle, at that speed a yaw rate of 40 deg/sec seems normal to the naked eye. Also, the lateral G force of  $-6.86 \text{ m/s}^2$  (69% of G) seems normal, close to letting the tyres slip in that corner but again, it's possible.

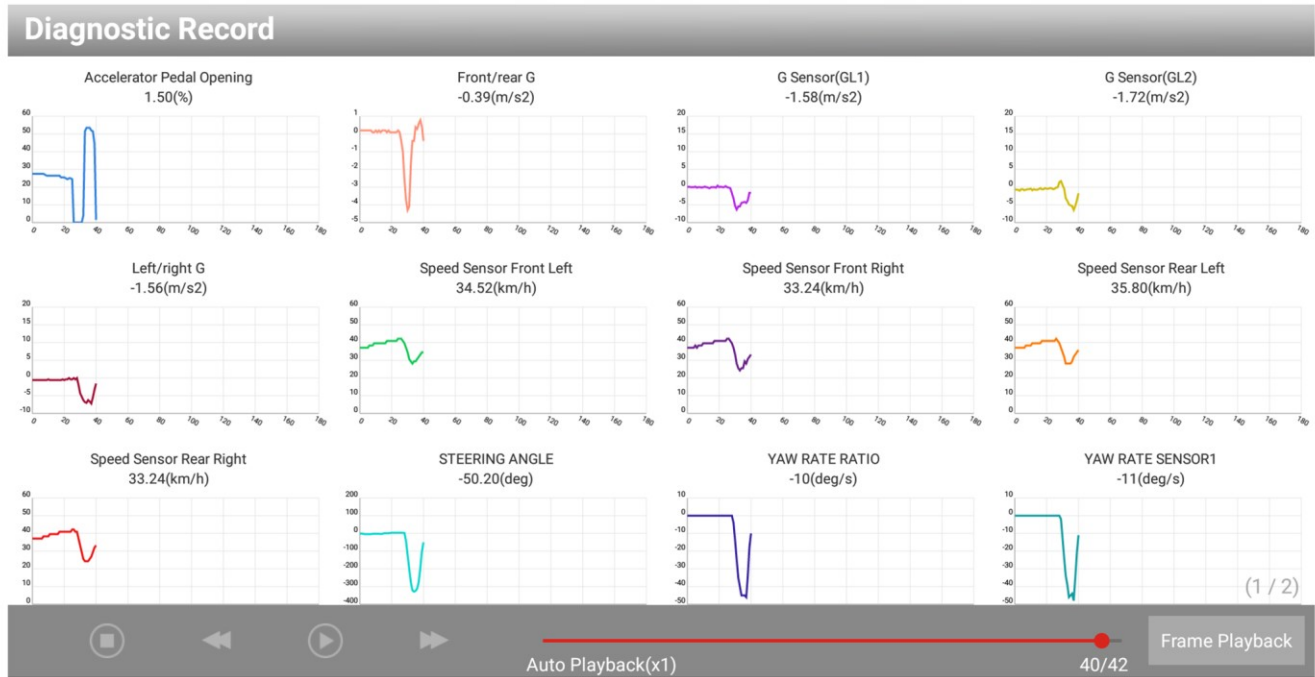
### Launch Scantool recording of the good car.

At frame 35 the steering angle is  $-324.5^\circ$  at that time the yaw rate is 45 deg/sec. The lateral G force is  $-5.15 \text{ m/s}^2$  (52% of G) again close to letting the tyres slip in that corner.

Could the different readings be perhaps as a result of the different vehicle speeds? The yaw rate and lateral G force are certainly vehicle speed-related. On the bad car the speed of the Front left wheel is 37.1km/h on the good car 40.9km/h just before the steering wheel has been turned. Hmm... we are not sure now, lets go back to the beginning before we go much deeper.

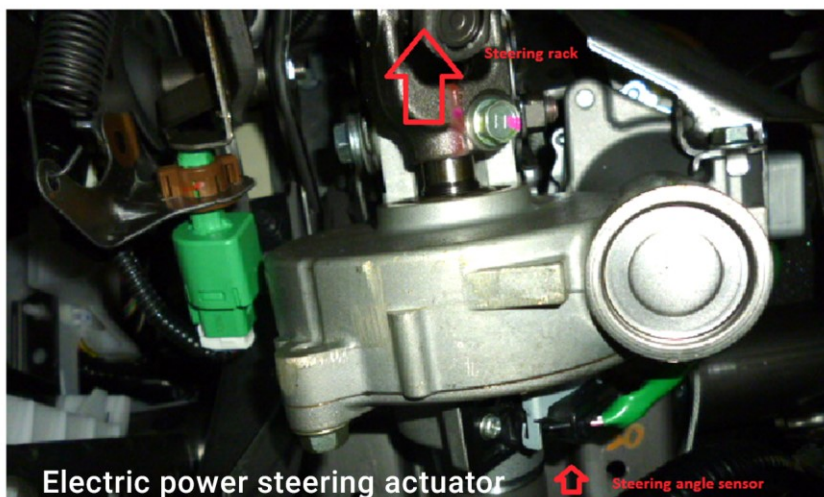
I asked the diagnostician if it perhaps was possible that by fitting the rack the steering angle sensor was damaged as a result of the very different steering angle in both Launch scanner recordings. Together with his picture, he told me that that would have been very hard to do.

The diagnostician also came back to me with that the job done on the rack was a pretty standard job as the old rack was full of water. We asked the diagnostician to exactly measure the number of turns from neutral to full lock.

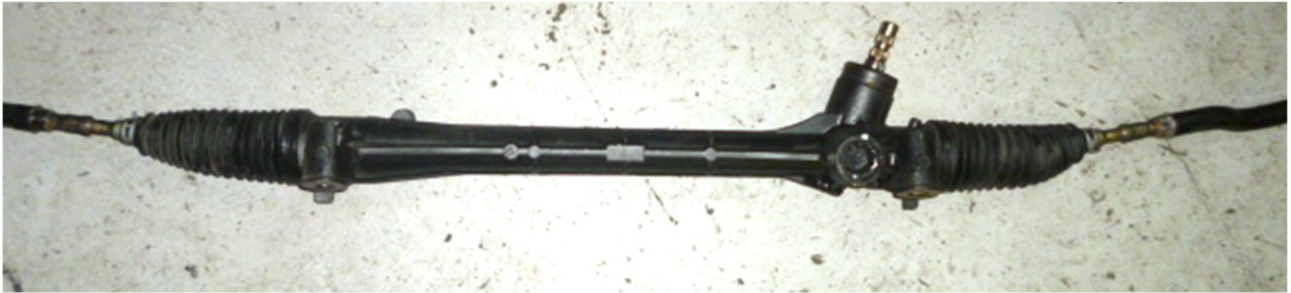
On the bad car, it took only 1.2 turns from centre to full lock, to a max steering angle reading of 490 degrees on the scan tool. On the good car, it took 1.8 turns to a max reading of 605 degrees !! ....

Apparently, the rack was rebuilt with parts from another model Toyota. Parts that look almost identical. The rebuilt rack had a different gear ratio than what it should have had, upsetting the relationship between the steering angle (sensor) and the actual corner the car took (yaw rate, wheel speeds and lateral G force readings).

**Steering rack Prius on the workshop floor.**

Even before he called us back with the values, he swapped the rack from the good car into the bad car, which fixed the issue!!
