My new Oxygen sensor is faulty?

This is a true description of a technical case presented to AECS technical support team.

Mazda 6 2013 turbo common rail diesel 2.2L

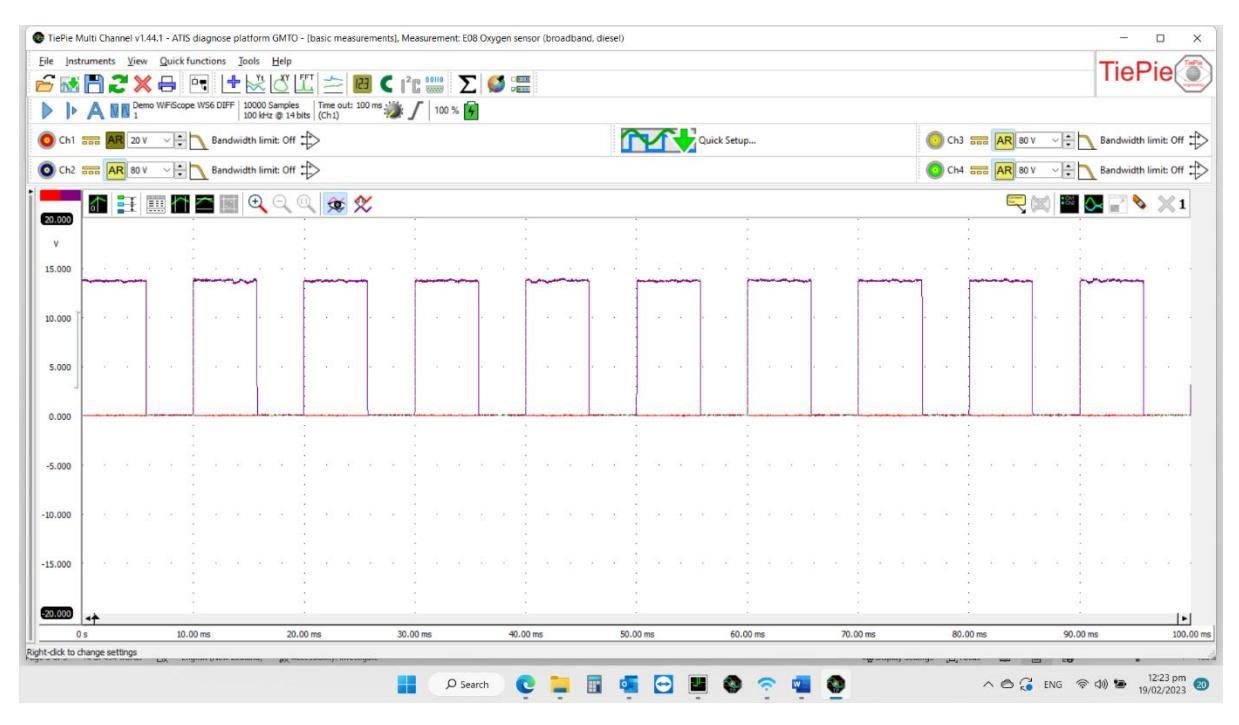
ATS scope recording of the Oxygen heater circuit operating correctly

The diagnostician reported back 14.4 volts flat line on supply wire and 0 volts flat line on the signal wire, where we should see the Duty cycle control.

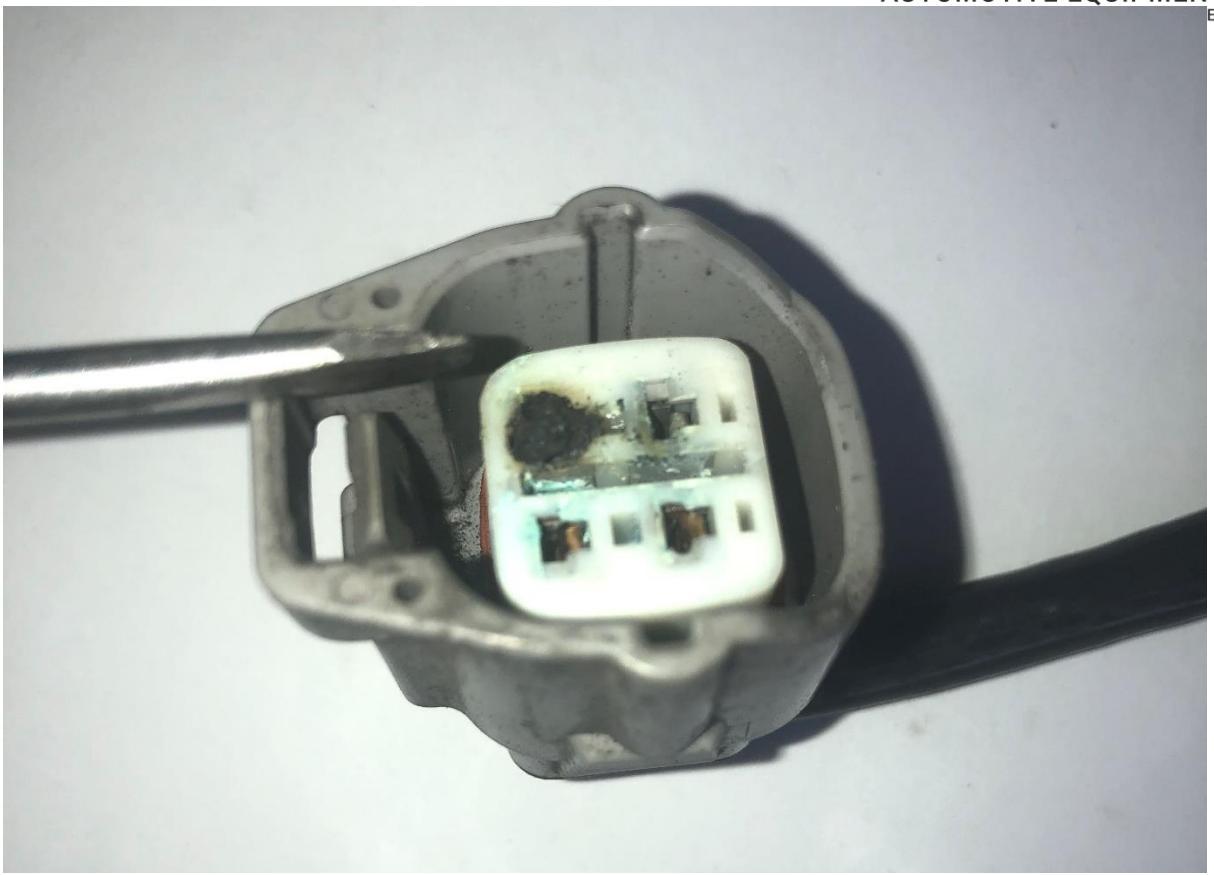
There are 3 possibilities for this oxygen sensor fault code. The sensor itself. Unlikely as it has just been replaced with a new genuine sensor. Wiring between sensor and engine control unit. Highly likely in this case as new sensor fitted. The engine control unit. Not likely at all but possible.

A full steady 14.4 volts was measured. The multi plug to sensor was removed and inspected. Please see the following picture what was found.

Multi plug connector pin with corrosion damage

Activated by the Launch scanner, the DPF was able to be statically regenerated with the oxygen sensor circuit repaired.
