Hi H1

This article is a true description of an AECS technical help desk problem and how it was solved.

2008 Hyundai H1 Common rail Turbo Diesel van.

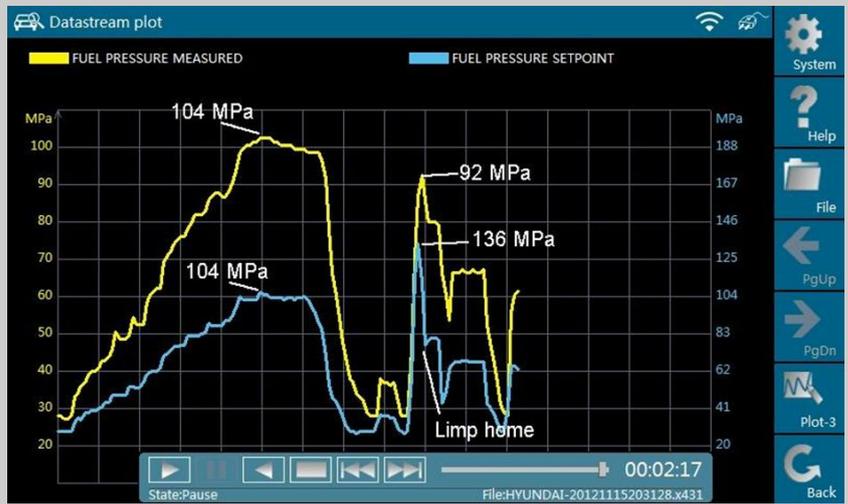
We used the Launch scan tool's recording function just to see where we had to go. (Picture 1) The actual pressure kept perfectly following the desired pressure

Picture 1 : Launch GDS scan tool recording of the actual rail pressure (yellow trace) vs desired pressure (blue trace). Please note the different MPa scales.

while slowly accelerating to cut off speed and decelerating (first part of the graph).

When full acceleration takes place the desired pressure goes up to 136 MPa but the actual pressure does not rise above 92 MPa when the vehicle falls into limp home, yet the pressure is able to get up higher than 92 MPa.

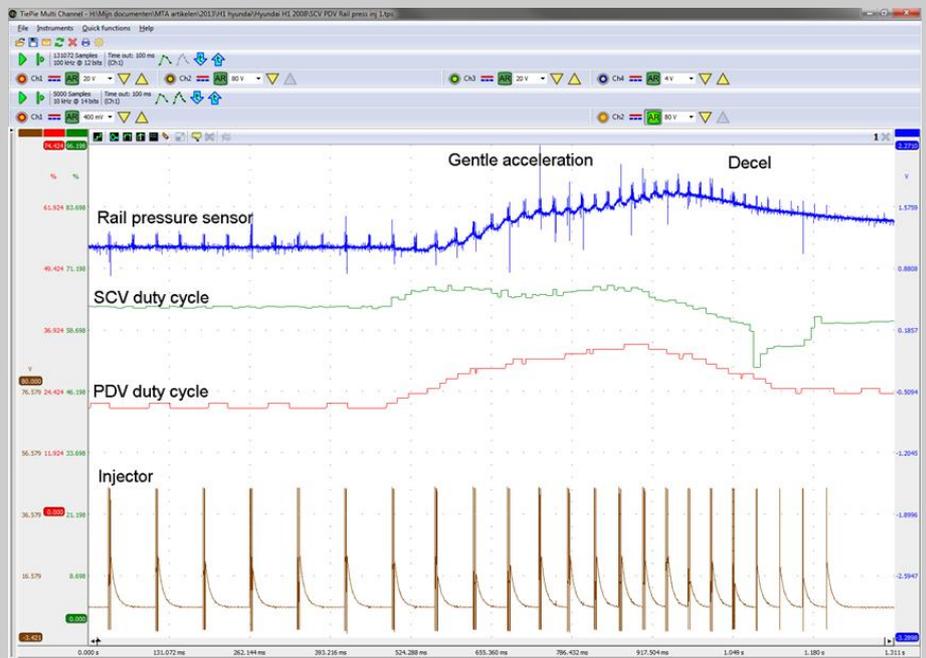
First, we accelerated gently, just like the recording with the scan tool. (picture 2)

Both the SCV and the PDV traces do not move to ridiculous values, meaning that the ECU has the rail pressure under control, i.e. the actual rail pressure follows the desired rail pressure.

Picture 2: ATS 4 channel scope recording of rail pressure, SCV, PDV and injector.

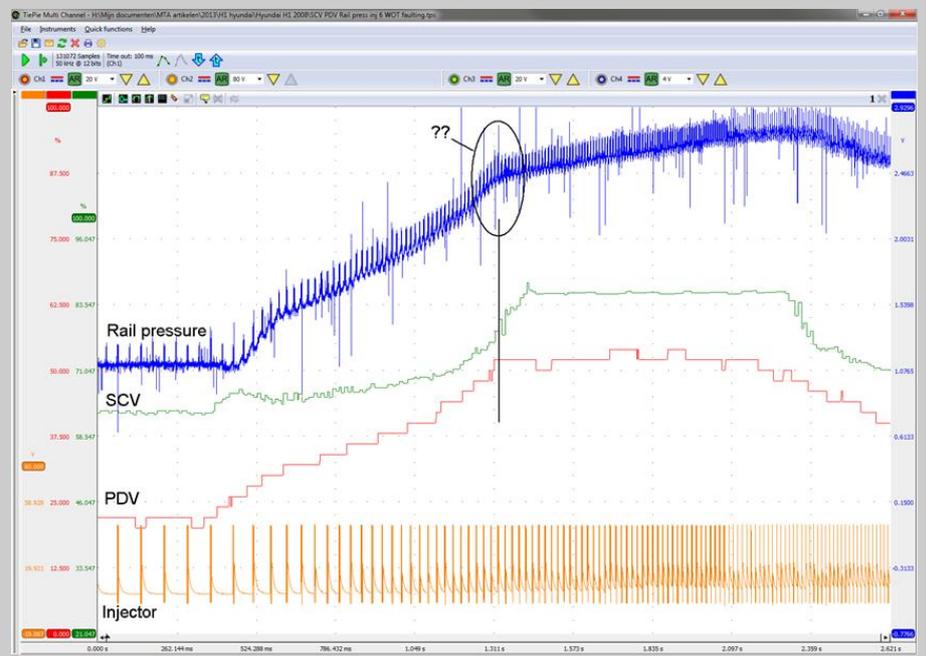
Next, we had to accelerate fully. (picture 3)

The full acceleration recording told us an important story. The pressure does not rise linear, at the indicated area and the pressure seems to suddenly stop rising quickly, yet the only items that are affecting the pressure (pump, SCV and PDV) seem not to be responsible for backing the pressure increase off.

Picture 3: ATS recording during full acceleration, when engine falls into limp home.

Look again at what is in front of us. Look at the scope recording where the kink is in the pattern. This looks just like the pressure graph of a mechanical Diesel pump increasing rotational speed, when the mechanical pressure relief valve opens to the return.

We checked the return line with a clear hose while the valve was fully activated (closed) with the signal generator of the ATS scope. During light acceleration a tiny bit of return flow was visible, but during hard acceleration full flow took place, just as the kink appeared in the graph.

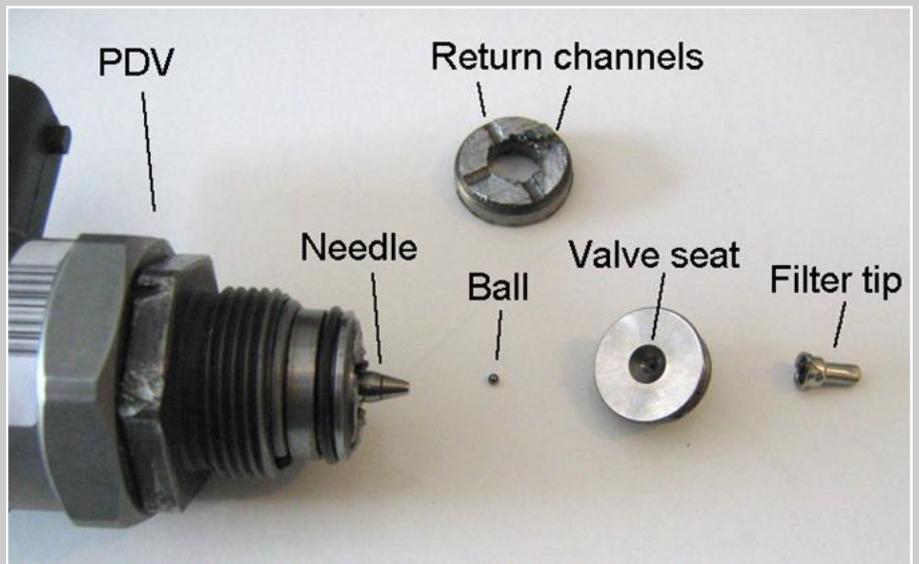
The old PDV was taken apart and some dirt was found in the valve.

The ball bearing needs to seal properly when the magnetic field of the solenoid pushes onto the ball. In this case a tiny bit of grit kept the valve open on a small leak, increasing the square surface area of the valve where the hydraulic rail pressure acted upon. An increase in

PDV exploded view.

pressure created a strong enough force to open the ball bearing valve in against the electromagnetic force the solenoid valve needle put on the ball bearing.

A new rail with PDV was ordered and fitted with perfect results.

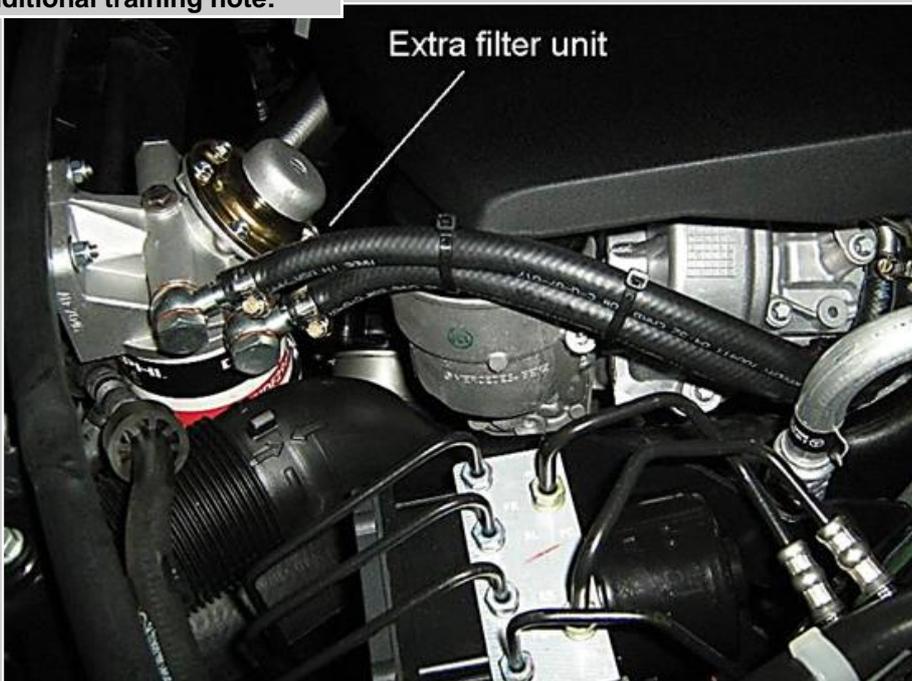
Extra filter unit with glass bowl (bowl not visible).

Use as hoses to and from the extra filter unit SAE 30R9 not SAE 30R7 as I did.....

During our DMS 1-3 common rail Diesel training, we advise to fit to any common rail Diesel vehicle (also brand new ones) an extra filter unit with water separation bowl. If water enters the fuel system, the pump, valves, and injectors need to be replaced. The genuine filters used on many modern vehicles are not having enough water separation area, plus the water sensor with
