Aircon-Conned: The saga continues!

The following article is an AECS technical help desk situation. We discuss, review and resolve.

Damage Report

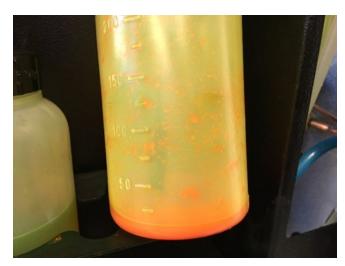
UV Dye Bottle

Aside from the positive stop leak test results there were obvious indications that all was not right in the UV dye bottle itself which could be seen just by looking at it. UV dye is normally yellow NOT orange.

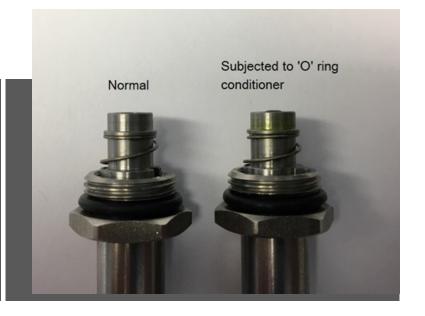
The UV dye solenoid housing and valve also showing evidence of Stop-Leak.

Most manufacturers of stop leak and A/C top-up add a chemical which is often referred to as '0' ring conditioner designed to soften old and hardened seals. In reality, this causes nothing more than the seals to swell permanently out of shape. Look closely at the seal in the end of the solenoid on the right in the picture above compared to the solenoid from an identical uncontaminated machine on the left.

The seal has swollen and is bulging out of its housing. It's this "conditioning" of rubber seals which causes many of the initial machine symptoms and in this machine prevented the seal from doing its job correctly. Refrigerant, oil and the stop leak it contained were able to leak back from the internal manifold into the UV dye bottle where the refrigerant boiling off forced the dye out of the bottle and all over the inside of the machine.

The cost of cleaning, flushing and rebuilding the machine in the pictures on top of replacing the sealed unit compressor made the job prohibitively expensive, the machine was a write off.

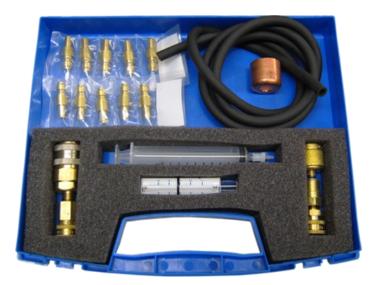
A/C Stop Leak detect kit.
