NO-GO Colorado

This article is a true description of an AECS technical help desk problem and how it was solved.

2015 Holden Colorado 2.8 Ltr Turbo Diesel FXH

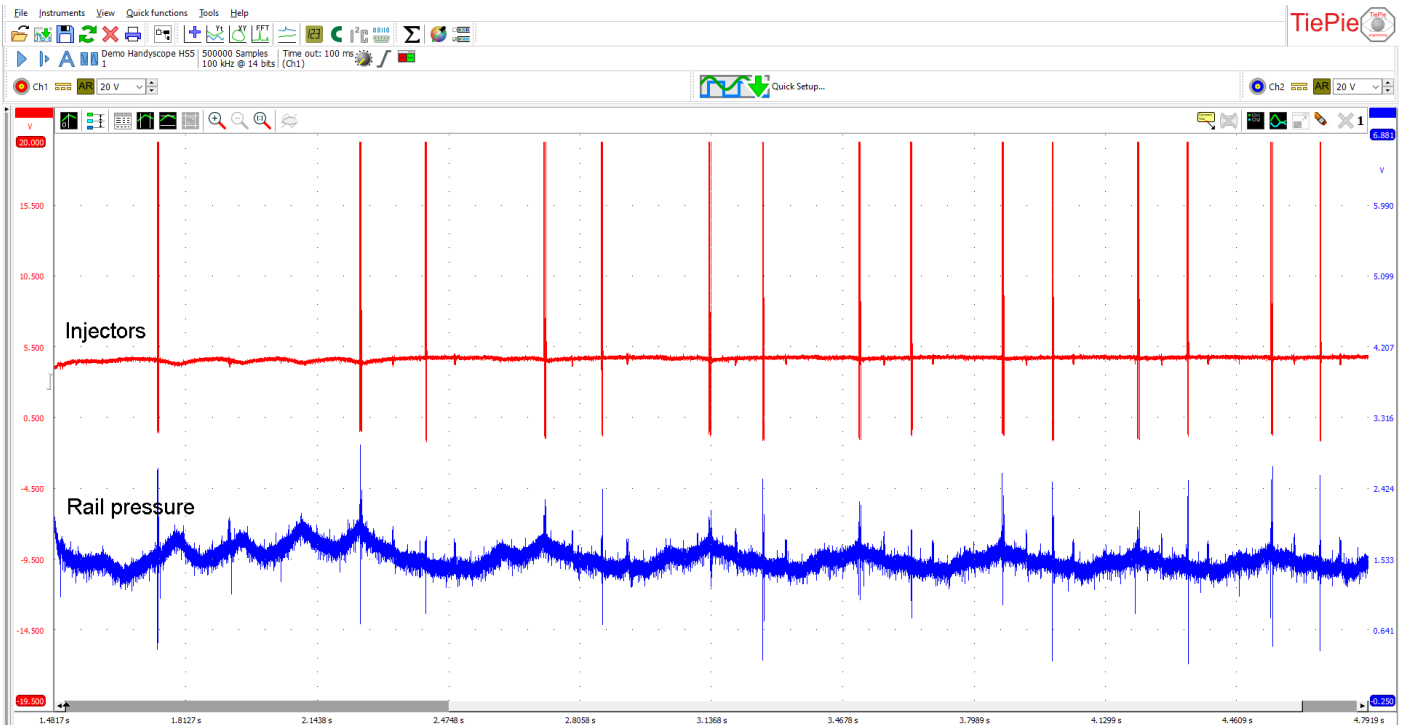
ATS scope recording rail pressure and injectors

We can see Rail pressure coming up ok as soon as you crank and injection is occurring, this means that there is enough rail pressure. So why does it not fire?

For now ignore the rail pressure (and SCV learning), as that is not your problem.

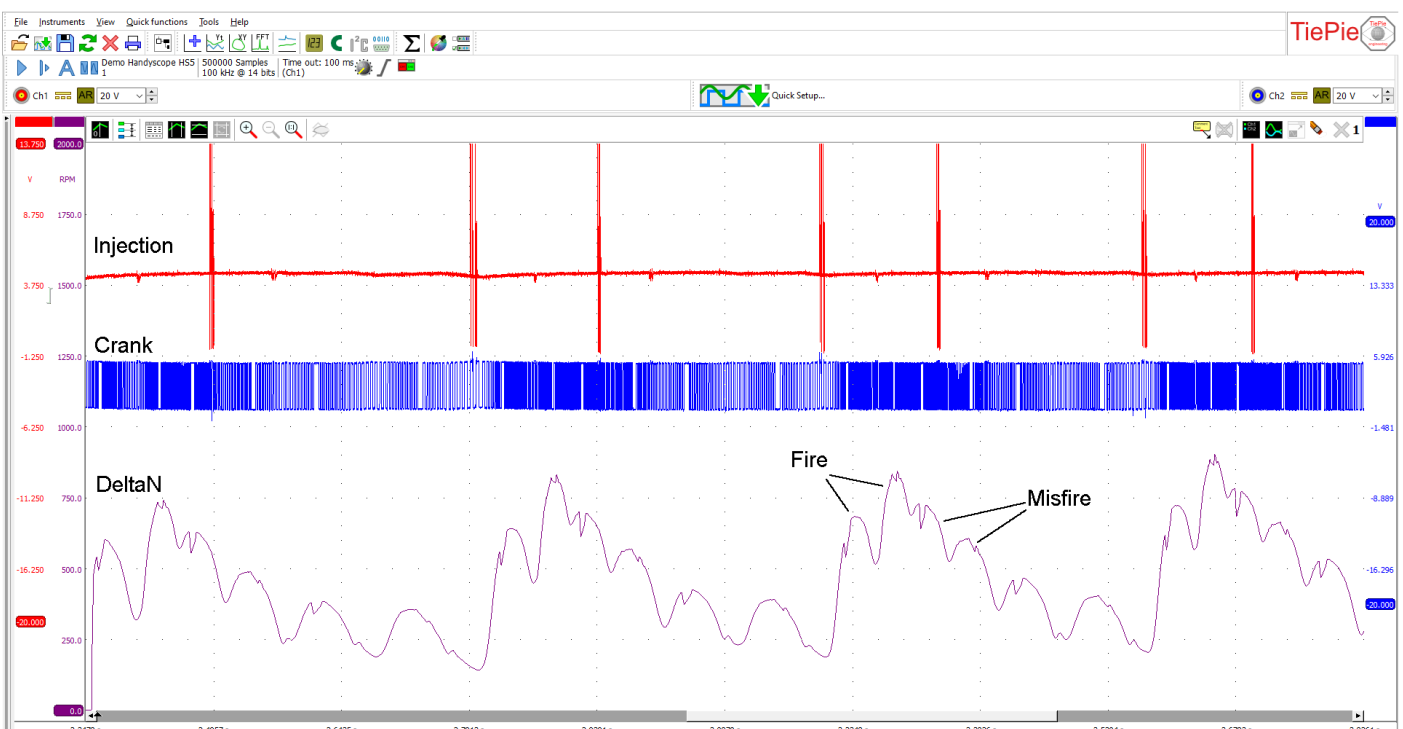
ATS scope recording Injection and crank

The Injection and Crank recording shows us that all compressions are good, and importantly that there are in fact only 2 cylinders that are firing and not even regularly. Not enough energy to keep the engine going.

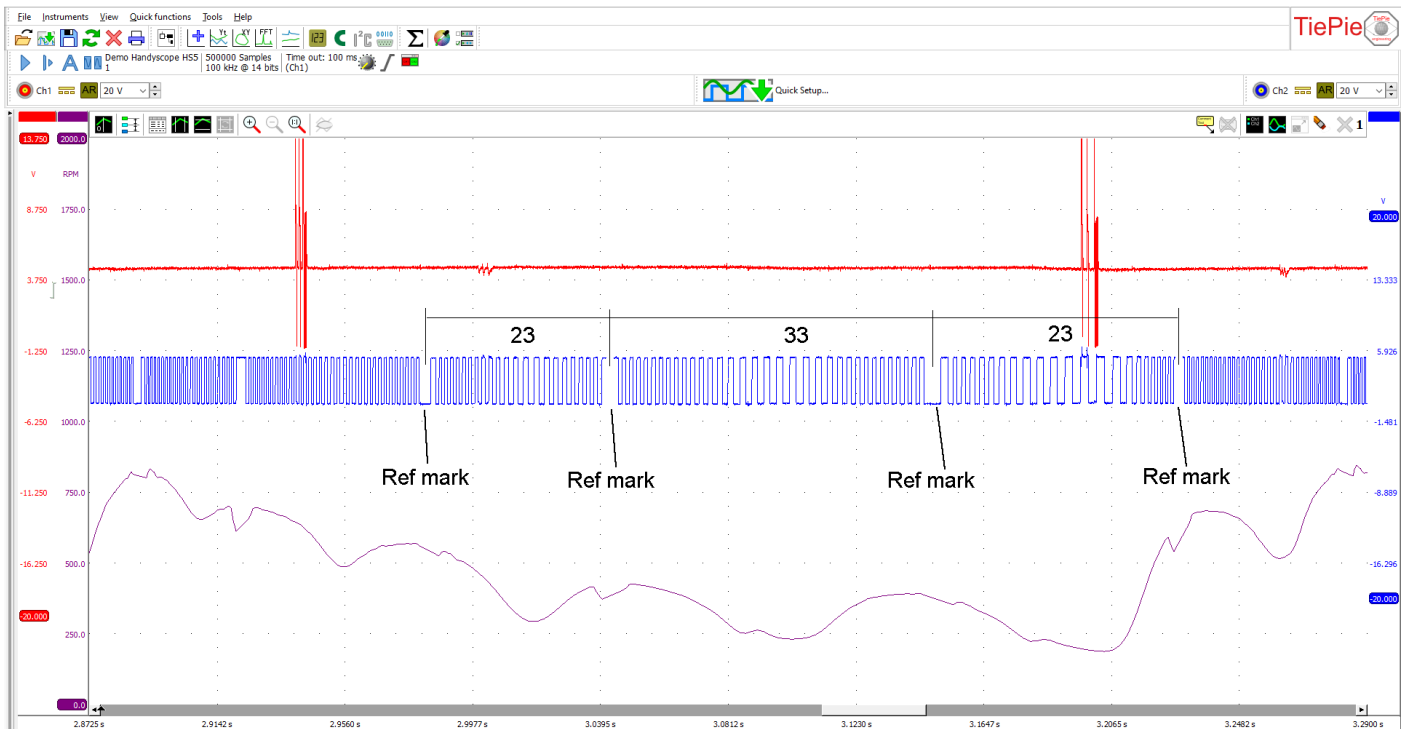
Zoomed in recording injection and crank

I have never seen this in my diagnostic career! The spacing between reference marks is always even every revolution, The teeth count between reference marks is always a logical figure. In this recording we see 23 teeth and 33 teeth. Added up 56. This makes no sense.

We advised the diagnostician to have a decent look at the tone wheel as we suspect that there is something wrong with the teeth, mechanically or magnetically.

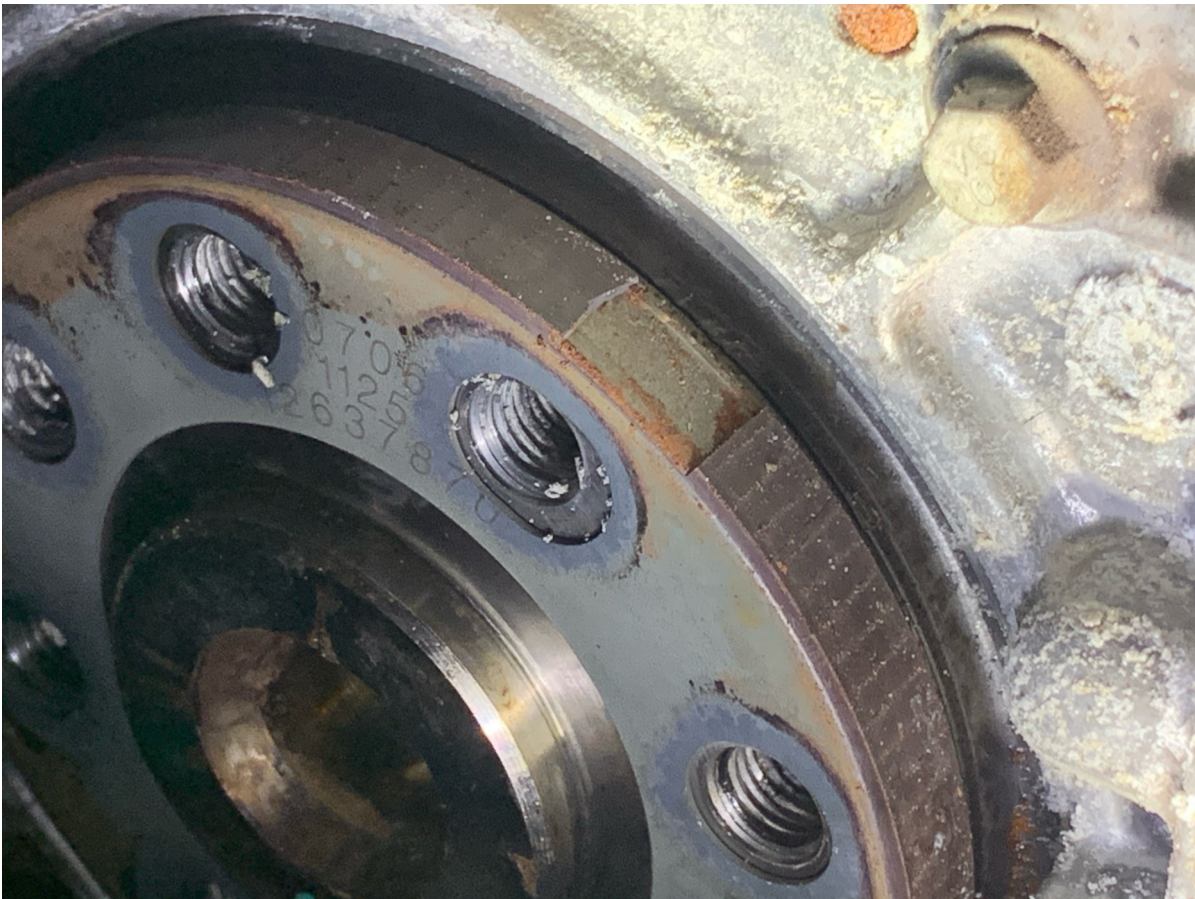
Magnetic tape tone wheel of the Colorado, spot the missing piece.

Amazing! Part of the magnetic tape of the crankshaft tone wheel is gone. That missing part was read on the scope as the second reference mark. The ECU saw the same and could not work out when to inject the remaining two cylinders.

A new tone wheel was pressed on the crankshaft (in situ), the flywheel and transmission was fitted back again. The engine started immediately and ran fine, no codes either. The diagnostician was so kind to send us an after recording of the crankshaft and injector signals.

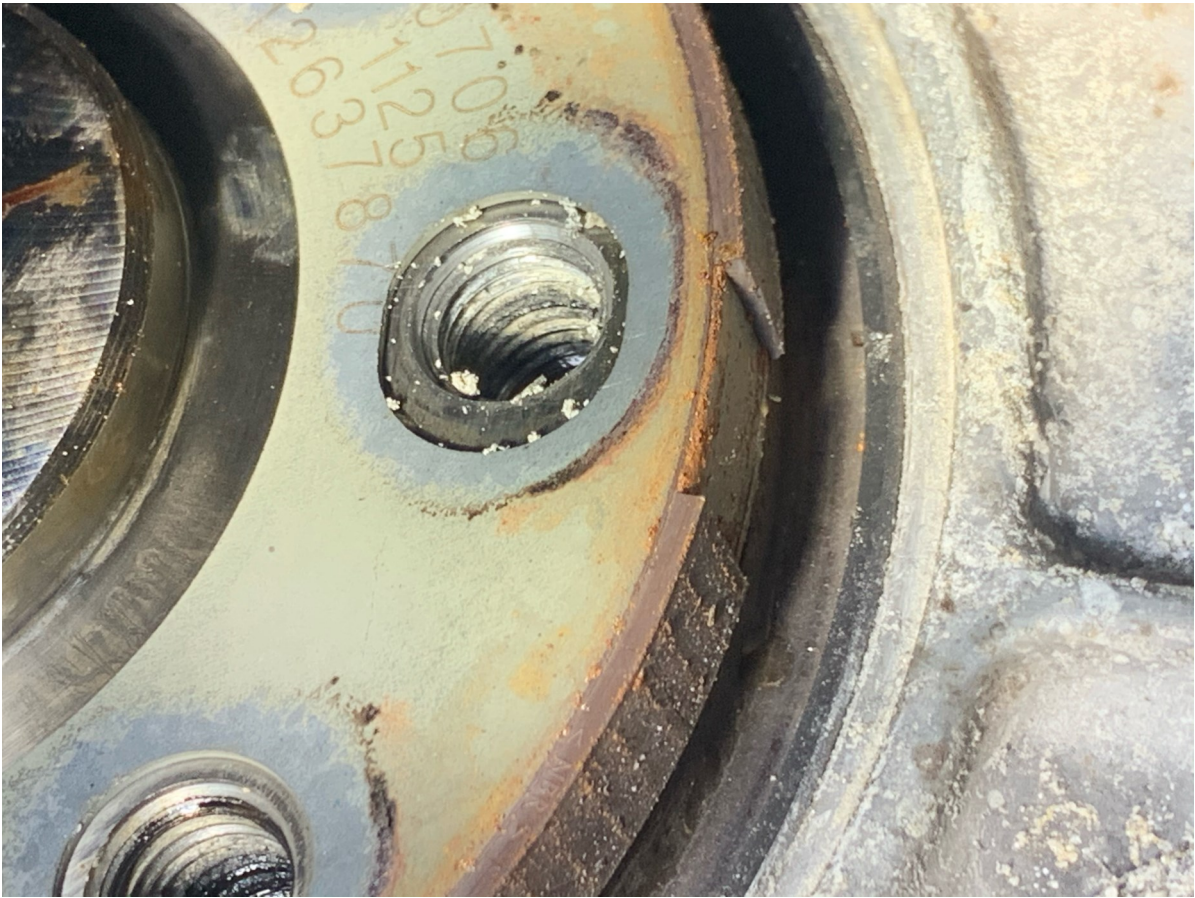
Close up detail of the damaged tone wheel

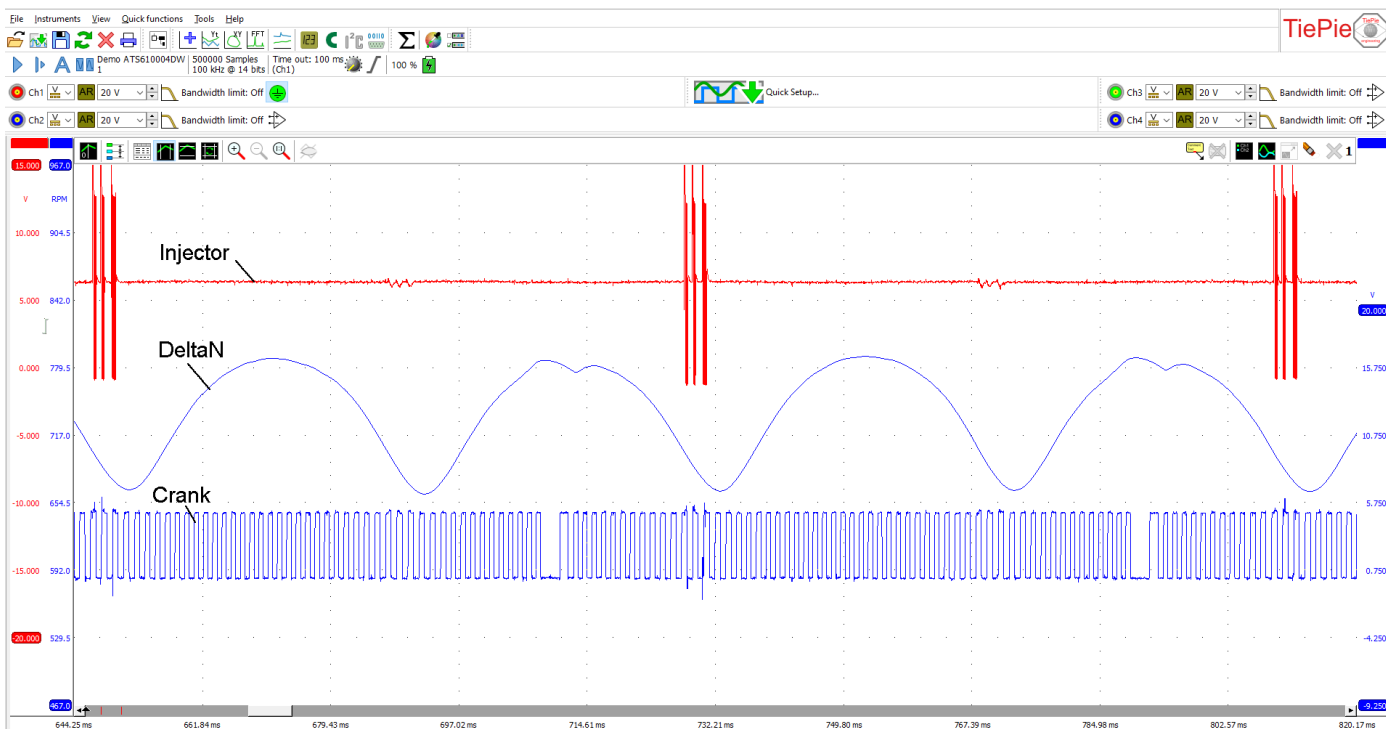
ATS scope recording after repair.

As you can see on the DeltaN line, there are perfect even compressions and combustions every revolution. Also the injection takes place regularly.

No pump learn needed after all.

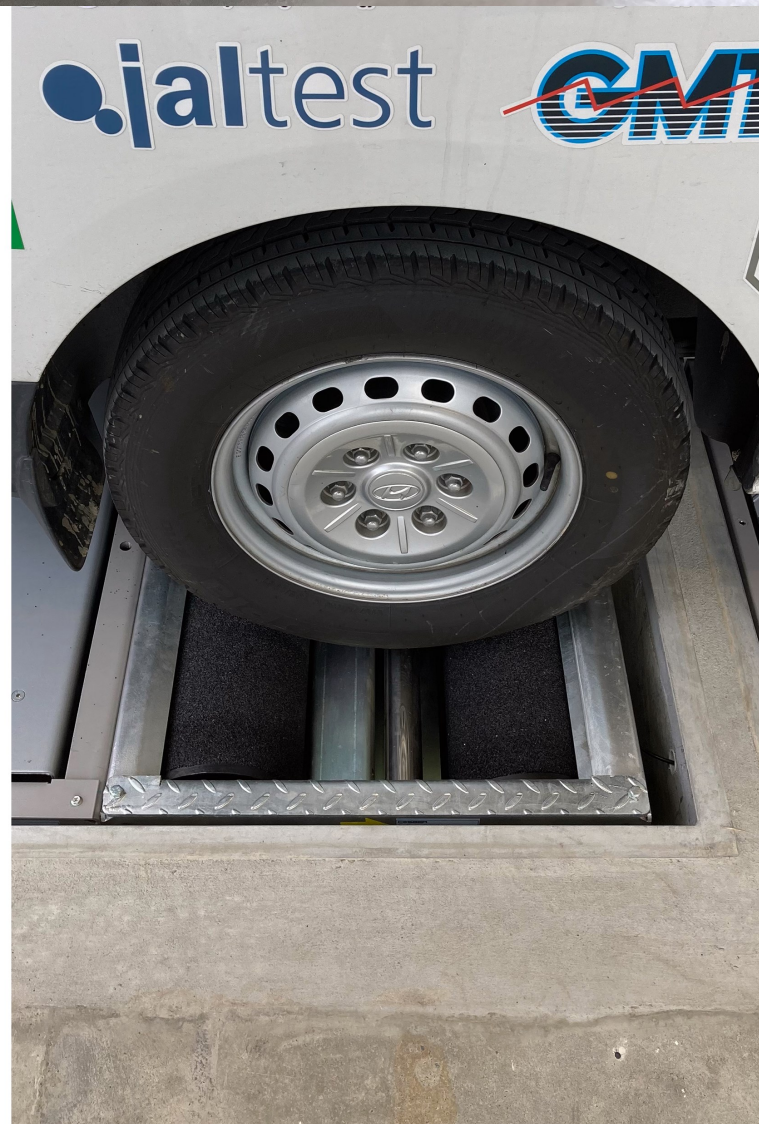
STT10e

- 8KN per wheel brake force
- 4x4 testing
- 4T axle load
- 3KW straight drive ABM (European) motor and gearbox with auto brake.
- Test axle width 800mm - 2200mm
- High precision, high grip, low wear corundum rollers. Wet >0.6 Dry >0.85.
- Roller alignment to prevent drag and (camber) pull, influencing brake force readings
- Hot dipped galvanized frame
- German industrial electronics
- NZ designed software
- Installed and maintained by AECS (nationwide, since 2003)
