Aircon update: Another one bites the dust!

During our October annual AECS equipment service and calibration trip, we found a near new AC recycle / recover machine destroyed by **STOP LEAK** which this time was unknowingly introduced by a substandard UV dye into the machine.

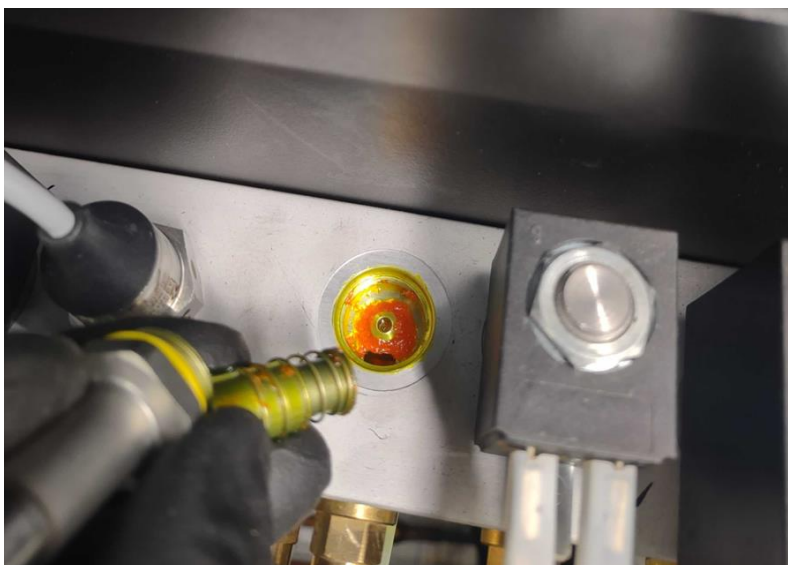
The complaint from this particular 11 month old machine was that the UV Dye injection did not work anymore. After removing the valve we saw an orange blob which is stop leak mixed in the UV dye used by this customer.

UV dye introduced Stop Leak.

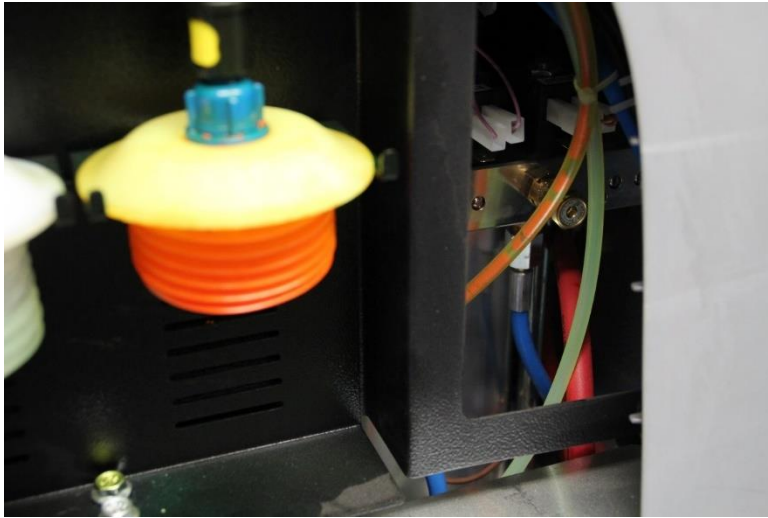
UV Dye mixed with Stop leak found during a previous service run. Look at the tube on the right.

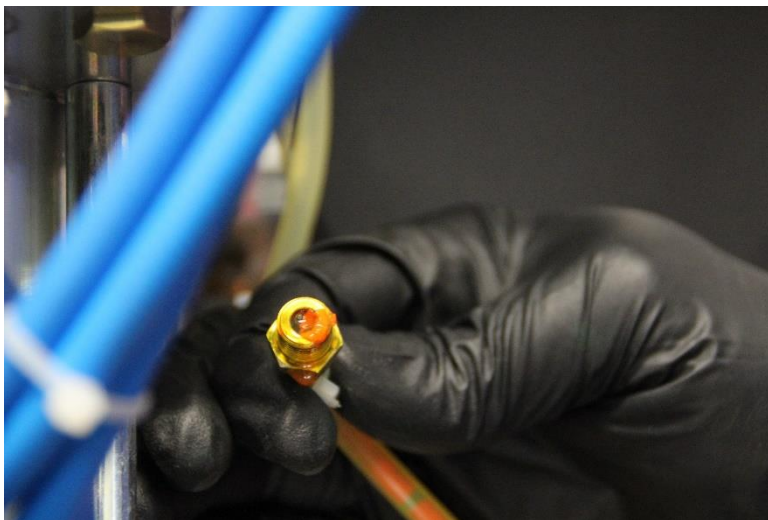
We have not opened up the rest of the machine but have found in the past that filters, and other valves in the machine are blocked by the same product, ultimately resulting in compressor failure and vacuum pump failure, because soon none of the other valves will operate anymore.

Valve blocked by UV Stop leak.

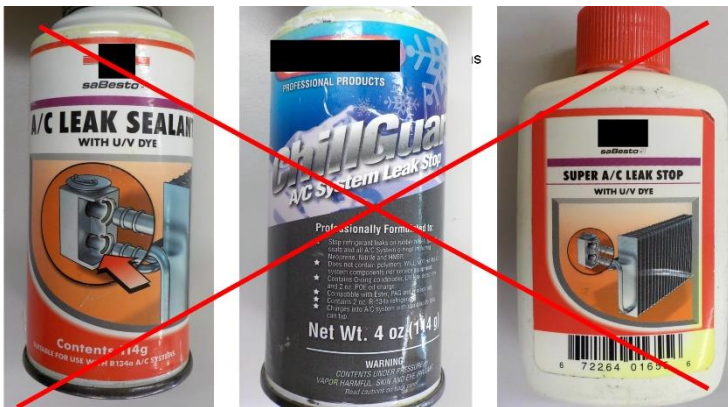
Samples of stop leak products

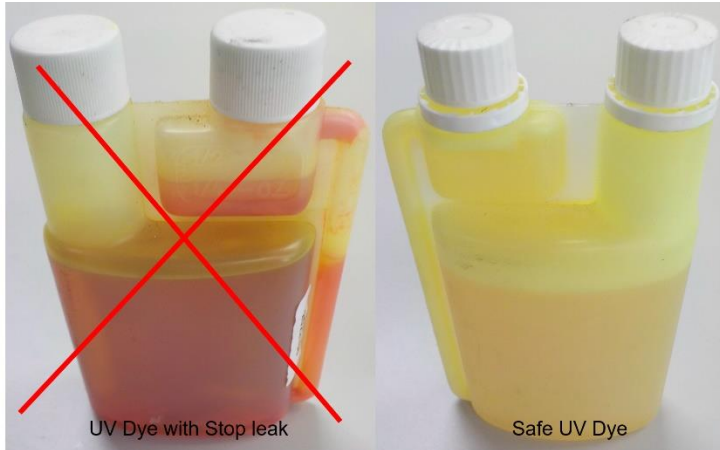
Two almost identical bottles of UV Dye, one contains Stop Leak.

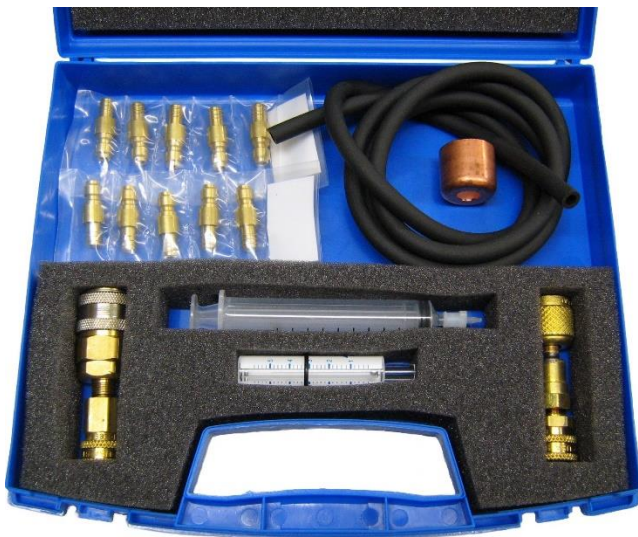
Stop leak can also be introduced in your machine by an infected AC system. We have a simple to use kit available that in a matter of 3 minutes will show if a system contains Stop Leak. The kit's detector can be reused over and over again until the replaceable detector gets damaged by Stop Leak.

AECS Stop leak test kit.
