Beaten BT

This article is a true description of an AECS technical help desk problem and how it was solved.

2011 Mazda 3Ltr 4cyl common rail Turbo Diesel WE-C

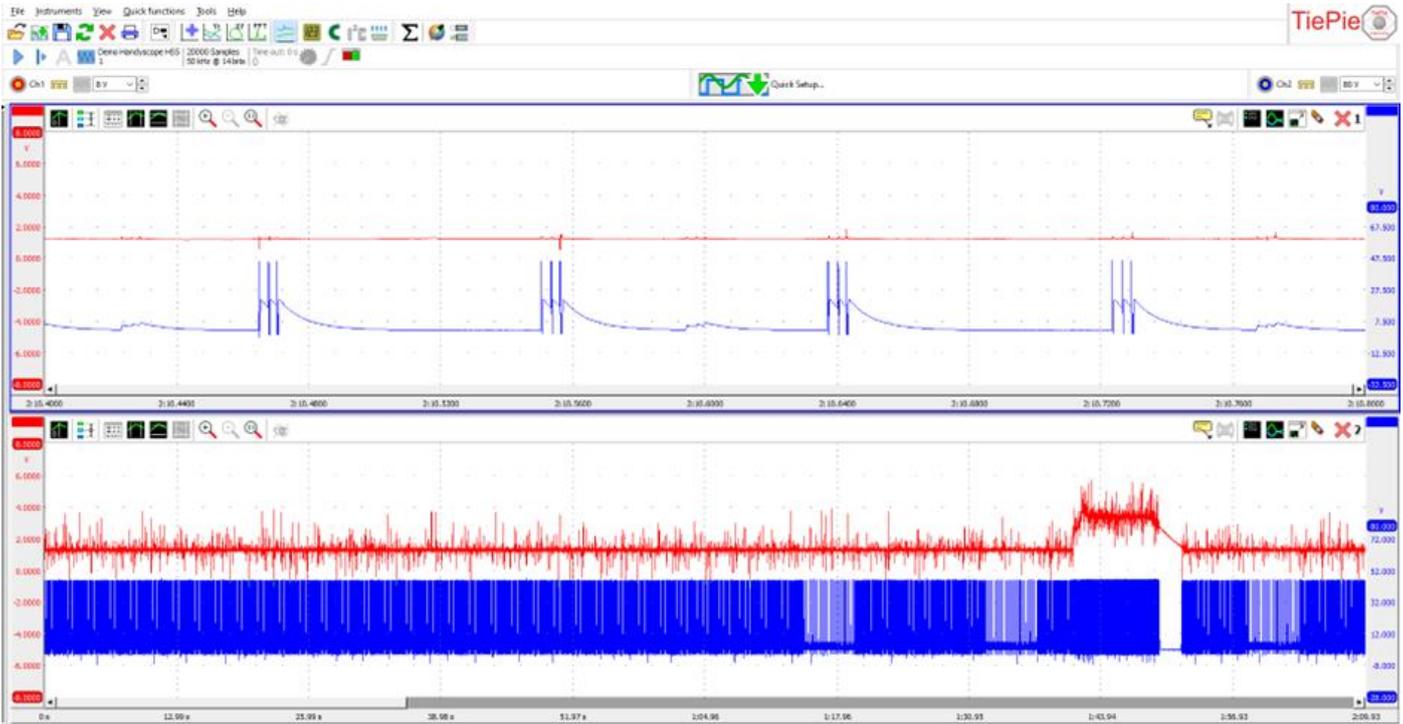
The following recording was made in the workshop, when the engine was idling with a slight misfire coming and going.

ATS 500XM data logger recording of injection vs rail pressure

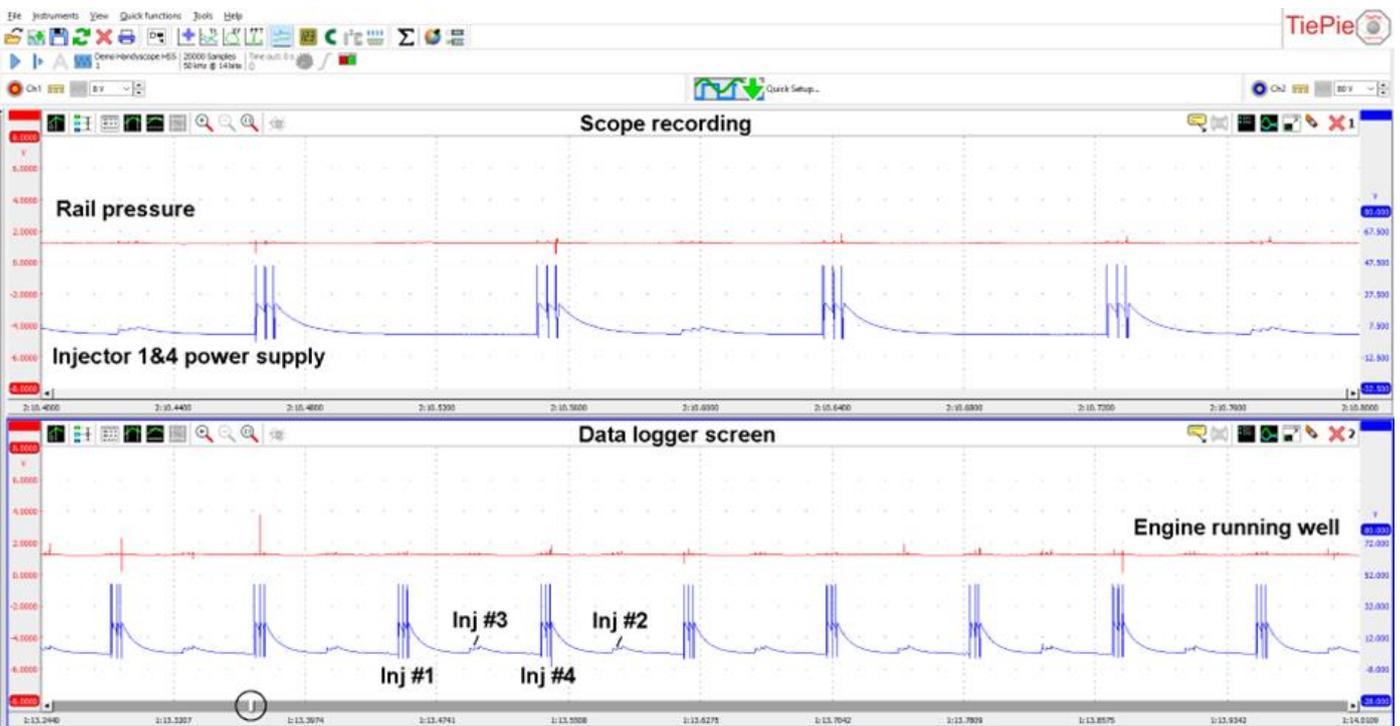
The bottom screen can be zoomed in and analysed, first for reference a recording where the car was idling while running nicely.

Same recording but zoomed in on a section where the engine was running fine

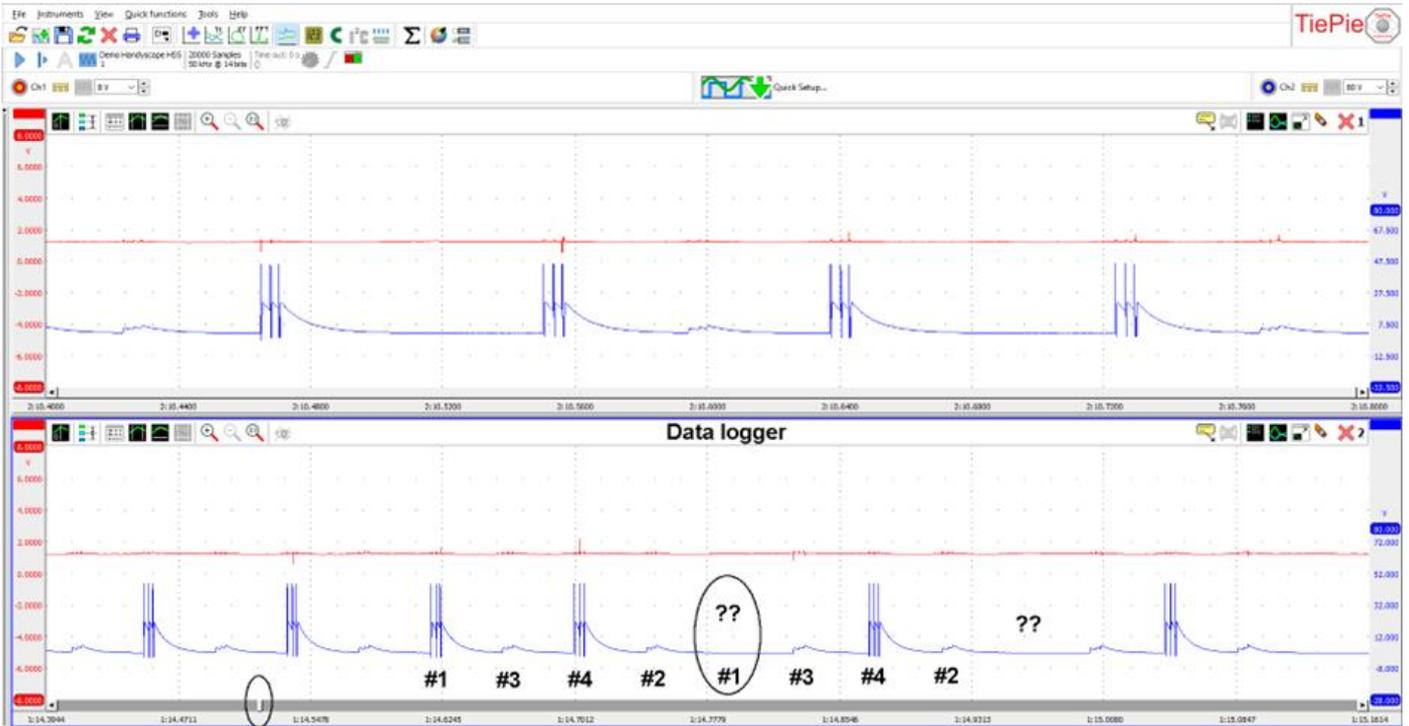
When scrolling through the data logger recording we stumbled upon a few patches where things were not so well.

Clearly visible in the data logger screen, is that the injector #1 signal disappears, and in the following section of the same recording (below) it reappears again.

We had randomly an injector cutting out electronically, this had 100% nothing to do with the fuel filter or aeration we expected in the beginning. Remember that is what it sounded like.

The injectors cutting out randomly can only ever be a small number of things, like

- 1) Power supply to the ECU
- 2) ECU failure
- 3) Crank shaft sensor signal not arriving at the ECU intermittently.

The power supply to the ECU possibility was immediately thrown out as the 5V to the rail pressure sensor remained present, we learn in the AED training how that 5V supply chip also powers up the CPU (processor). If the 5V (or earth) was faulty we should have seen that in the rail pressure sensor signal. ECU faulty... nah they simply hardly fail, that will be the last of our thoughts.

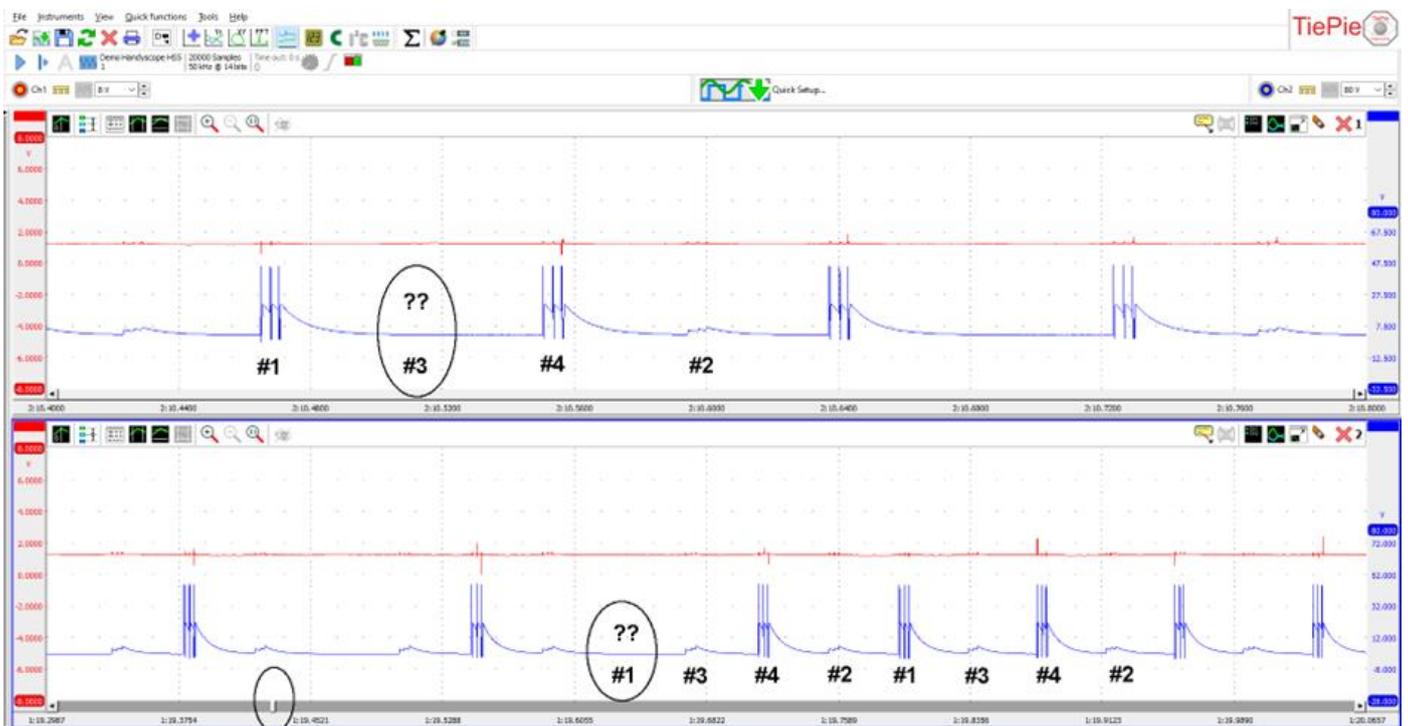
However also look in the oscilloscope (top) screen where the #3 injector signal has disappeared.

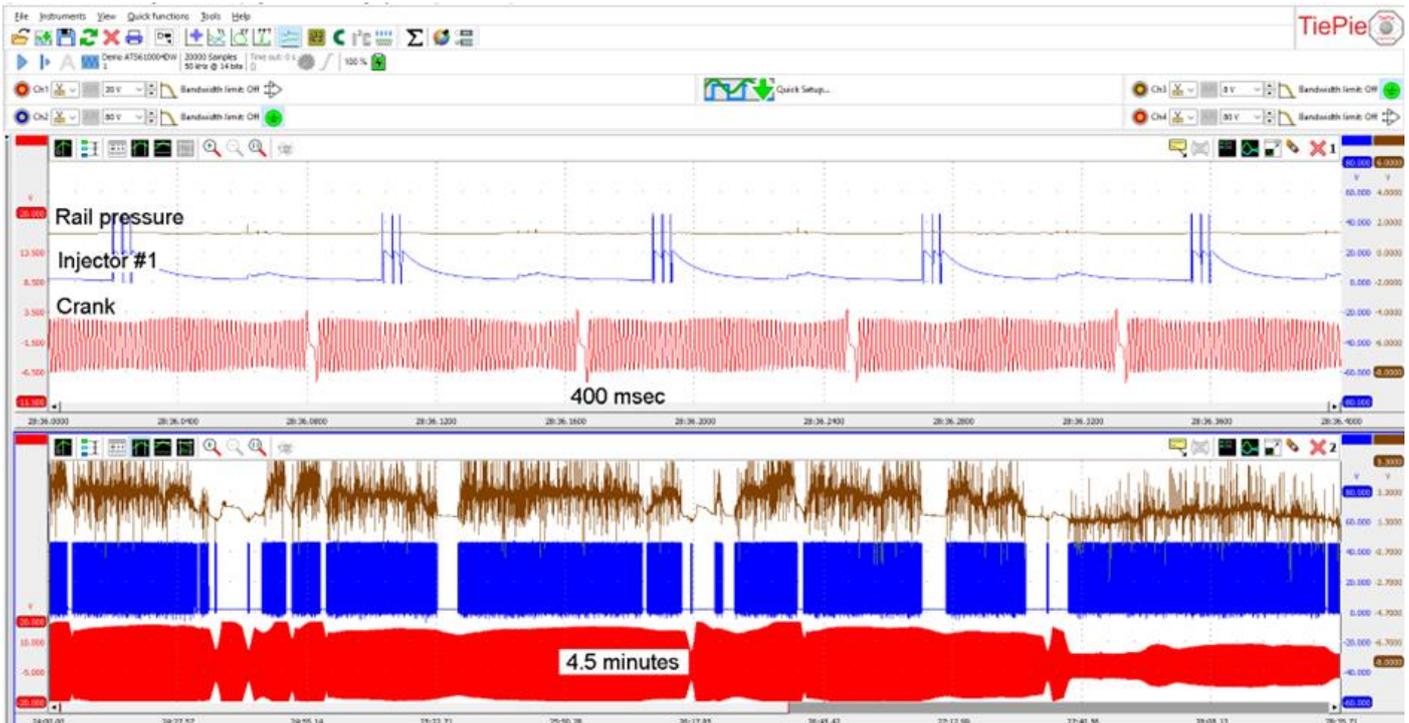
Let's have a look at the crank sensor signal to see if the input to the ECU is constantly present.

Rented ATS 6004XM scope, offset/differential scope recording

We needed to hook up to the crank sensor's signal wire, injector1 and the rail pressure sensor, for which we needed the ATS 6004 scope. ATS scope owners can rent and extra scope(s) if they need more than the channels they have on the screen, in this case only the 4 channel scope was used.

Wouldn't you know it, with the scope connected the car ran absolutely fine. Extensive recordings were made all with no misfire at all.

Frustration set in, as where do you go next? A bit of lateral thinking determined that the sensor's wiring on top of the bell housing must have been disturbed by the scope leads and probes hanging off the wiring. In simple terms the probes have maybe moved the wiring around enough to 'un-do' an intermittent short to ground.

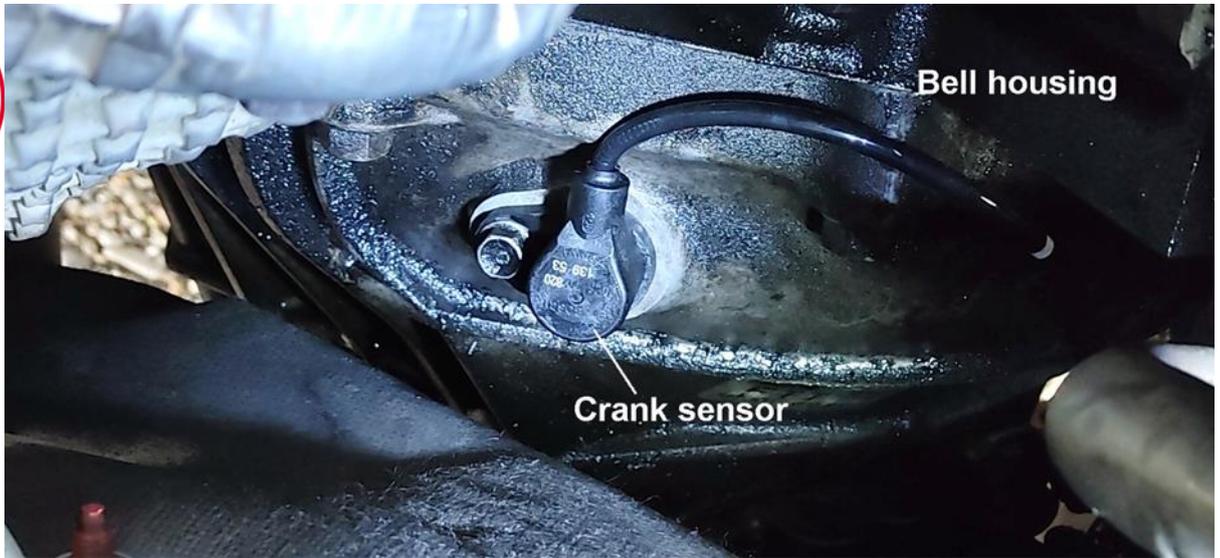
Location crank sensor

When fitting the sensor the technician noticed that the bolt holding the old sensor in the bell housing was loose, ready to fall out!

The sensor got replaced, since it was already purchased, securely fastened. The Mazda has been driving well for weeks now.

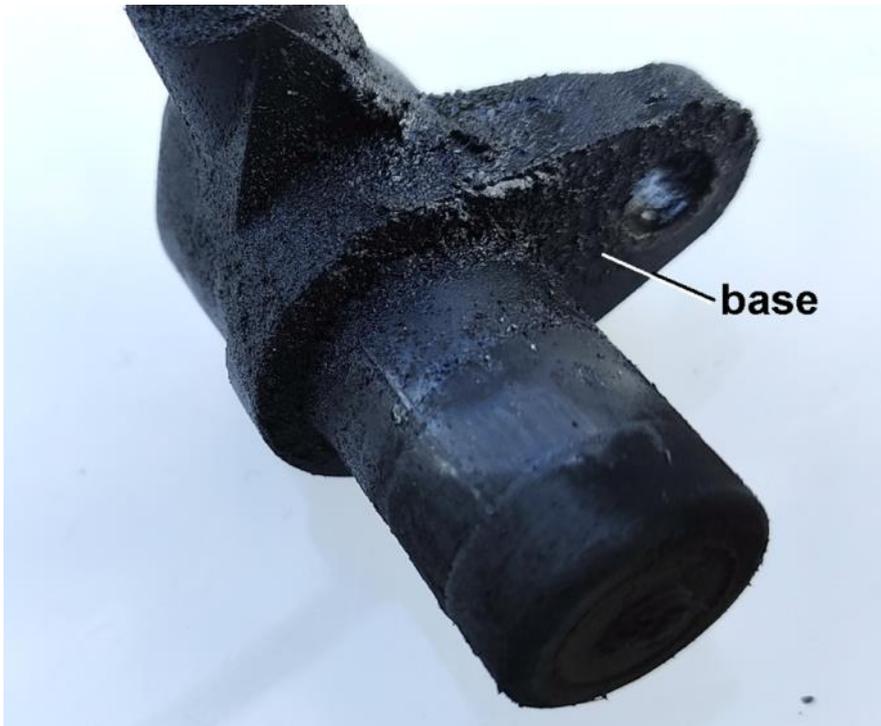
The wiring was perfect, not a mark, however the base of the sensor was dirty and had clearly been bouncing up and down in the bell housing

Sensor with dirt on the base and wear marks, indicating that it was not 'home' in the base for a longer period of time.
