Injection Rejection

2007 VW Golf 1.4 BLG 4cyl TSI petrol engine direct injection.

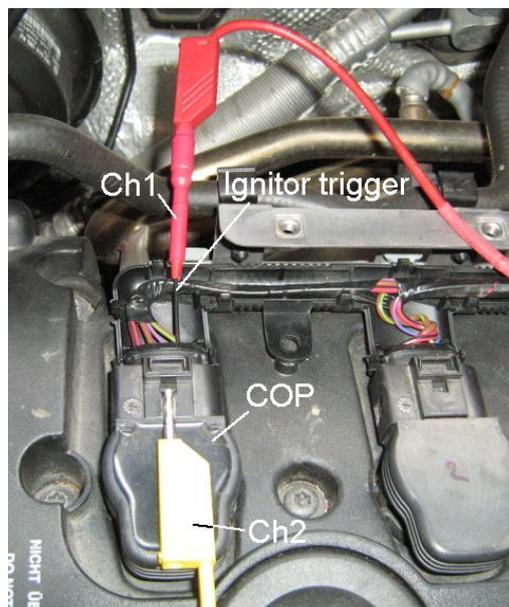
The coil on plug does not allow for a primary measurement, but with the sensitive ATS scope, an ignition pattern can be measured by simply holding a probe above the coil.

VW FSI ignition recording picture from the EMS 1-1 training seminar. CH2 will pick up the ignition pattern just fine.
